**Greenstone Pipeline Project:
Environmental Report**

FINAL REPORT

August 9, 2021

Prepared for:
Enbridge Gas Inc.
50 Keil Drive
Chatham ON N7M 5M1

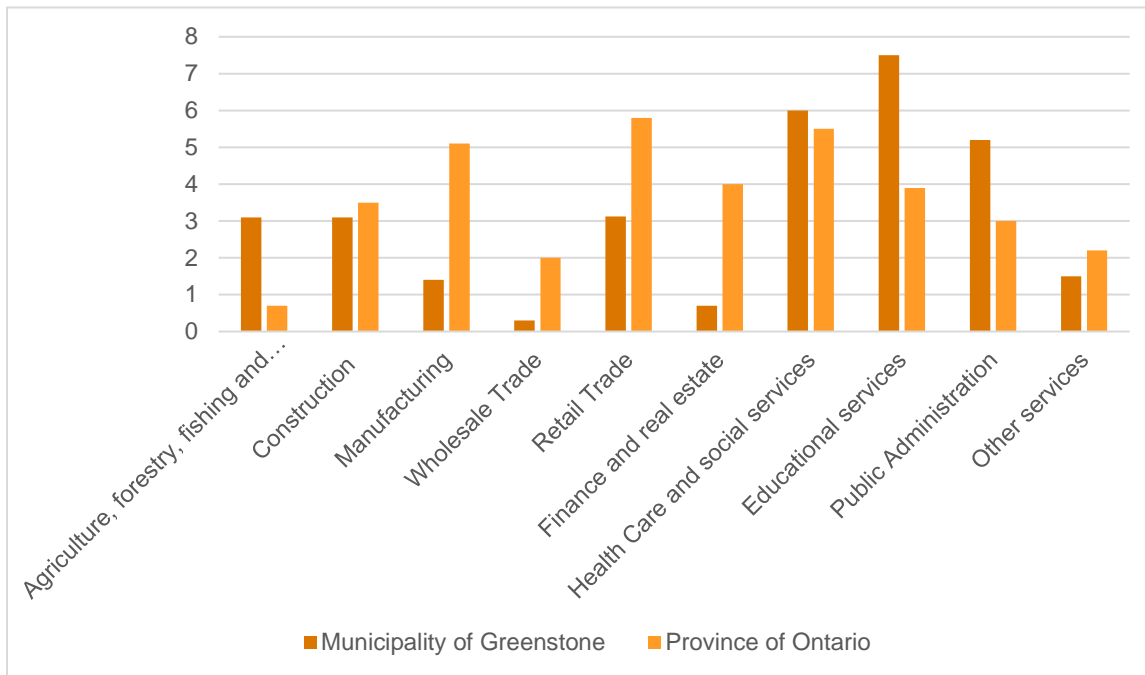
Figure 4.1: Distribution of Workforce by Percentage (2016)

Figure 4.1 shows the percentage of the workforce employed in the most common industries in Greenstone and Ontario as released by Statistics Canada (2007). Figure 4.1 indicates that educational services is the most common type of employment in Greenstone, accounting for 7.5% of total employment and exceeding the provincial average of 3.9%. Other types of employment, such as manufacturing, wholesale trade, and finance and real estate are lagging in Greenstone when compared to Ontario.

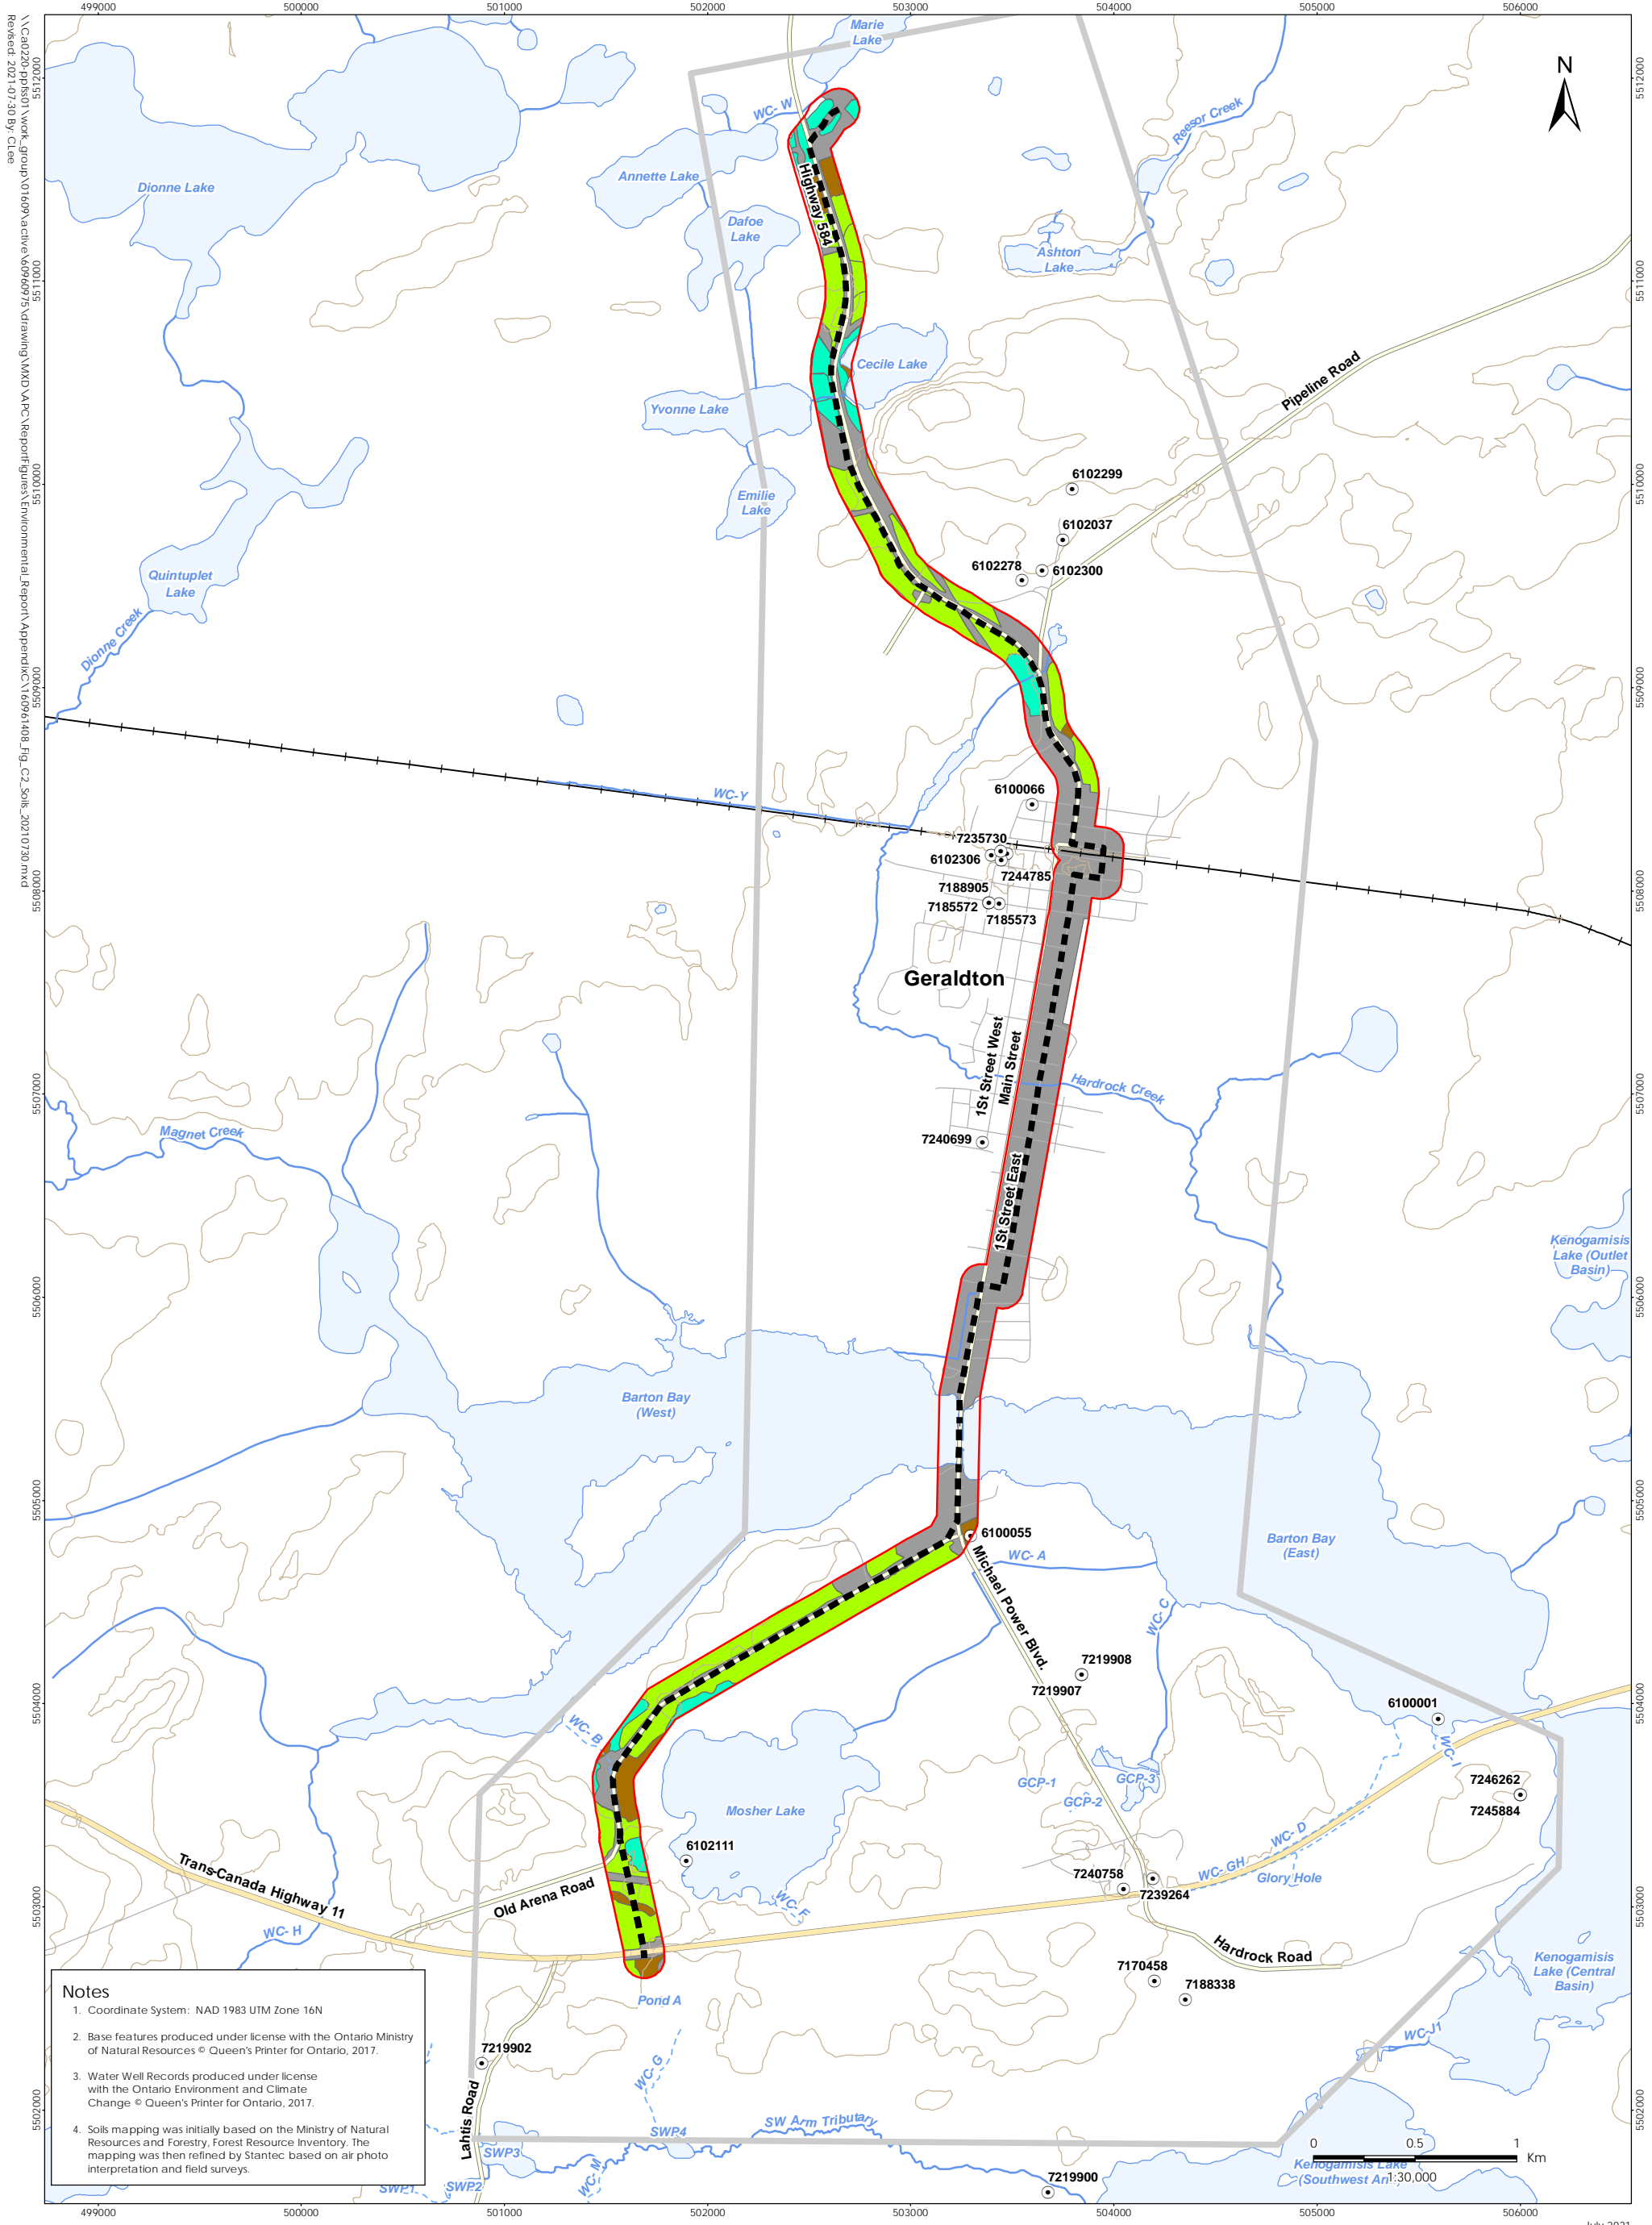
Figure No.
C2

Title
Soils

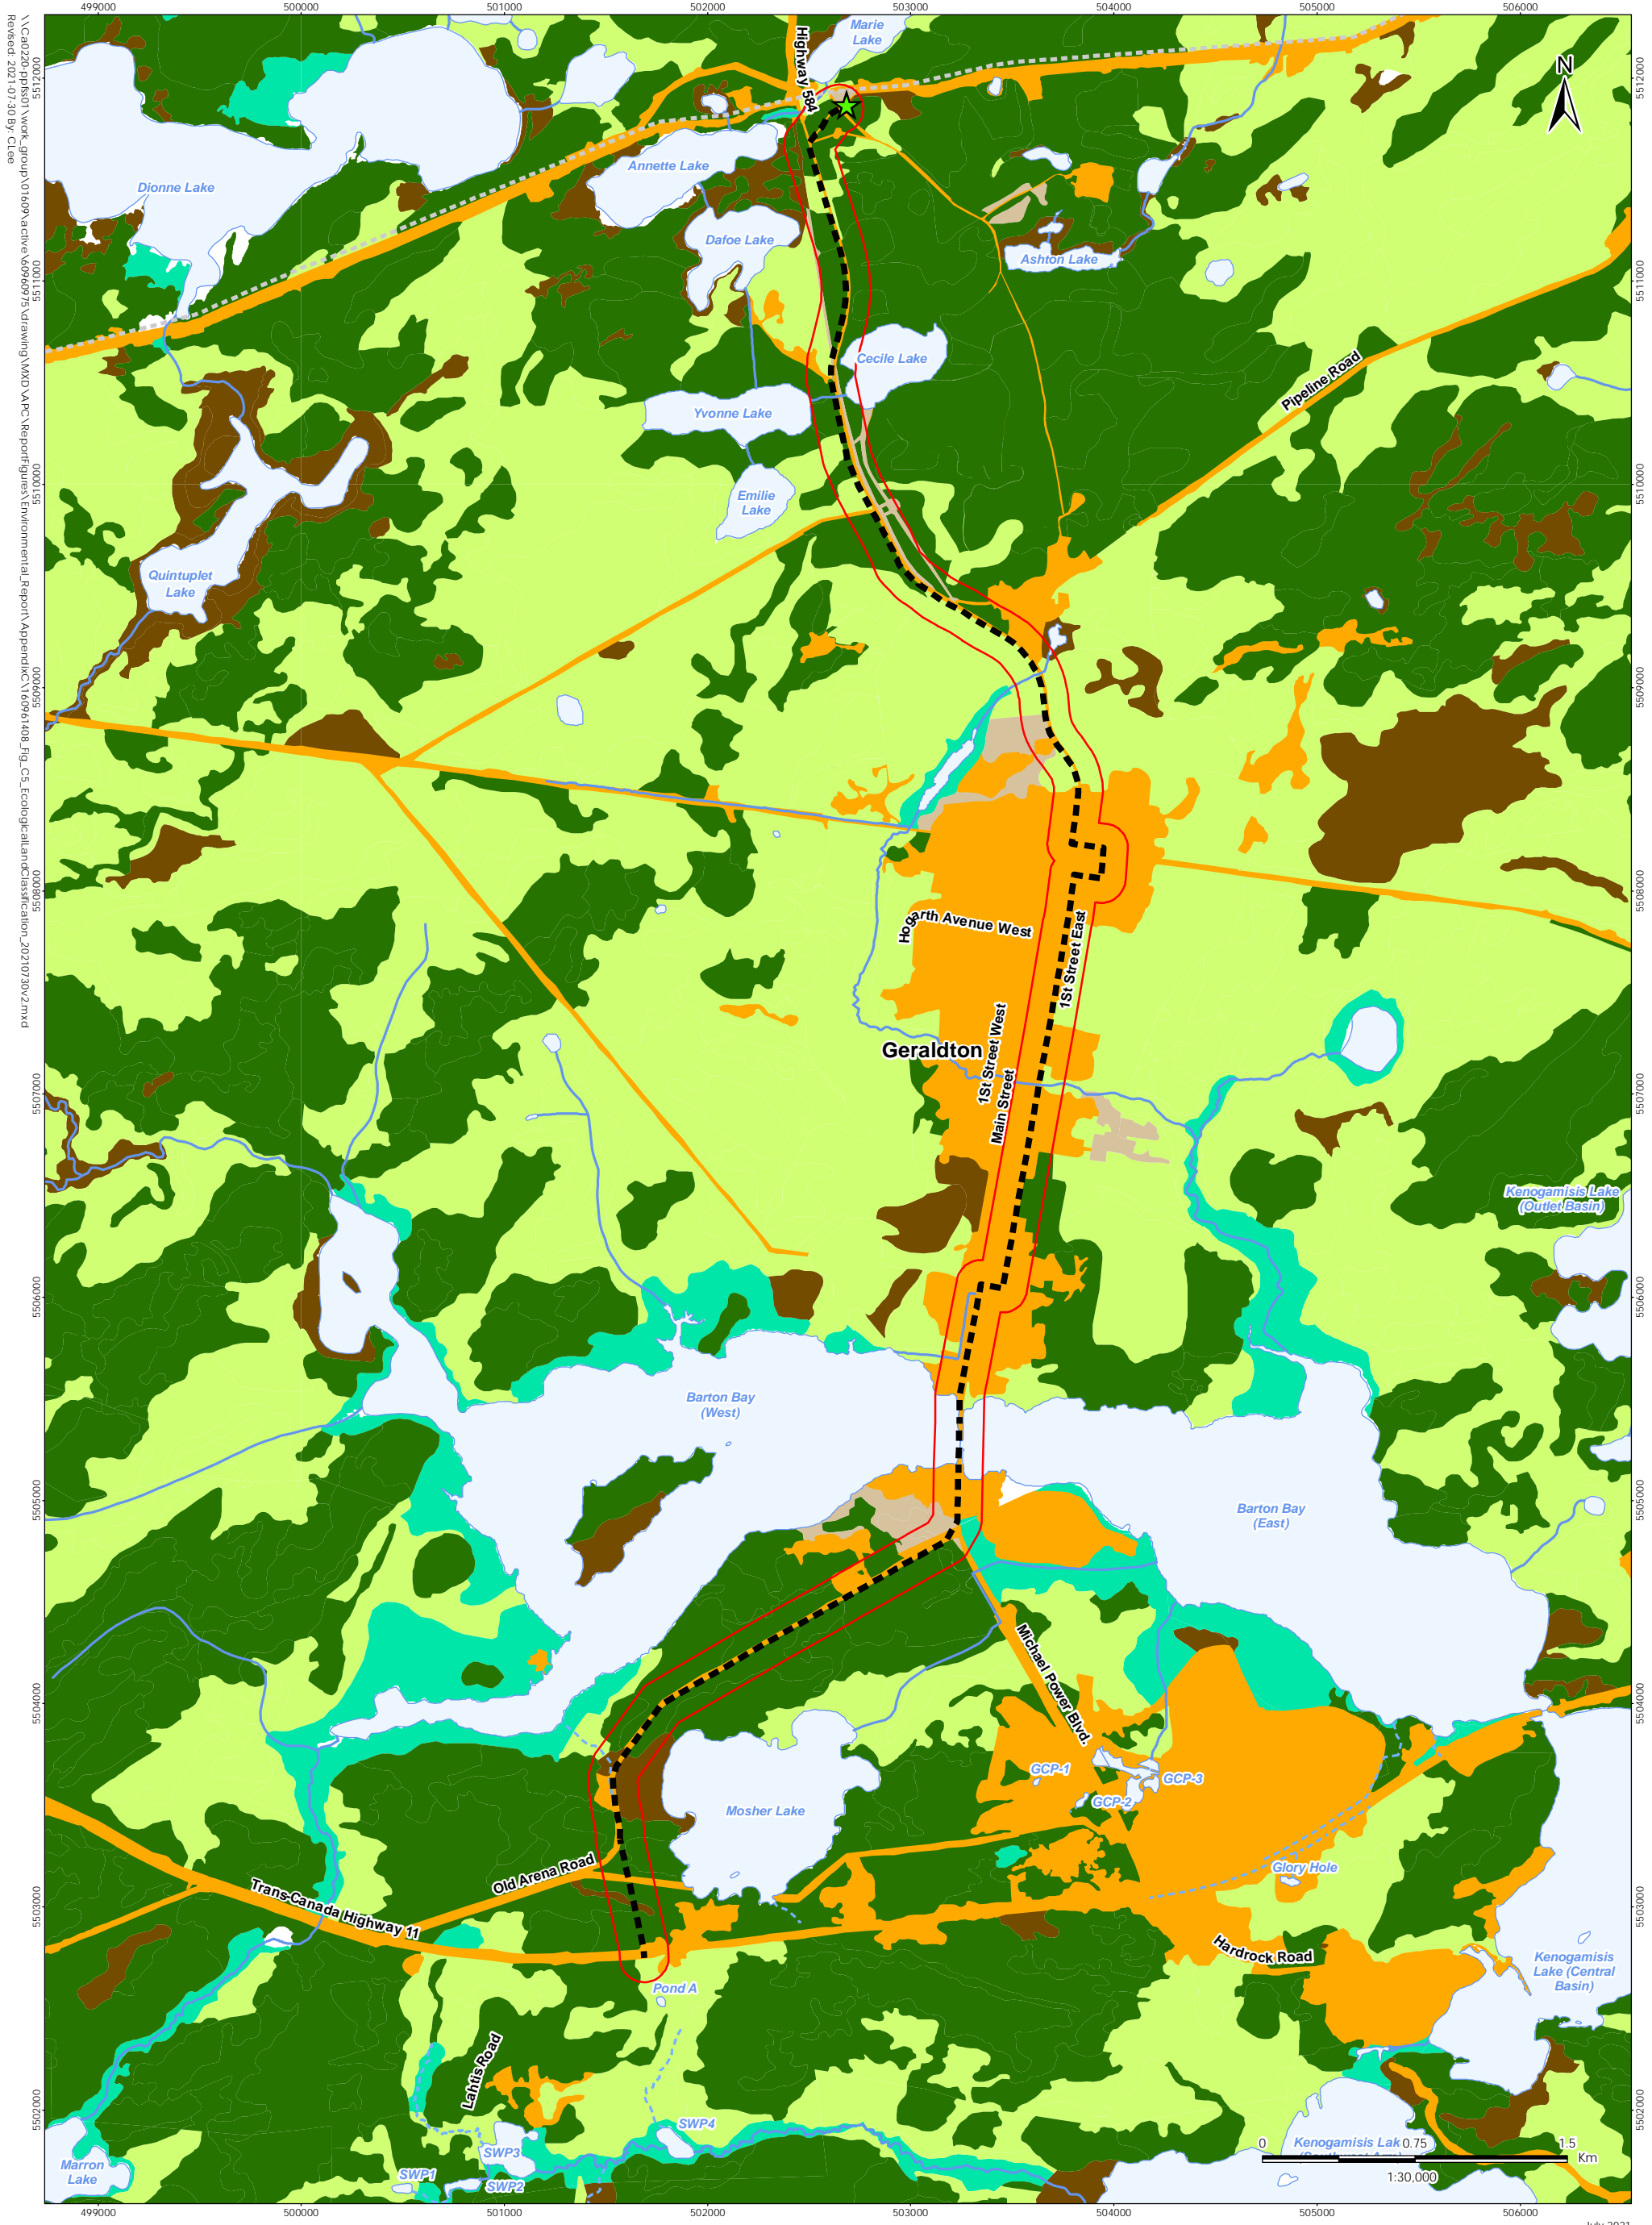
Along the preferred route corridor, three soil series were mapped: Dunbar, Scotia, and Muck. The Dunbar soil series, covering about 7 per cent of the Study Area, is from the Gleysol Soil Order. Soils of the Gleysolic order have properties that indicate prolonged periods of intermittent or continuous saturation with water and reducing conditions during their genesis (AAFC 1976). These soils are poorly drained. The Scotia Soil Series, covering about 34 per cent of the Study Area, is from the Brunisol Soil Order. Soils of the Brunisolic order can be characteristic of soils formed under forests and having brownish coloured B horizons (AAFC 1976). These soils are well drained. The Muck designation, covering about 9 per cent of the Study Area, represents an organic (muck) soil. Soils of the Organic order contain 30 per cent or more organic matter by weight. These soils are typically found in an environment that is saturated with water for prolonged periods. Organics include soils commonly found in peat, muck, bog, and fen environments. The soil classifications are shown on Figure C2, Appendix C.

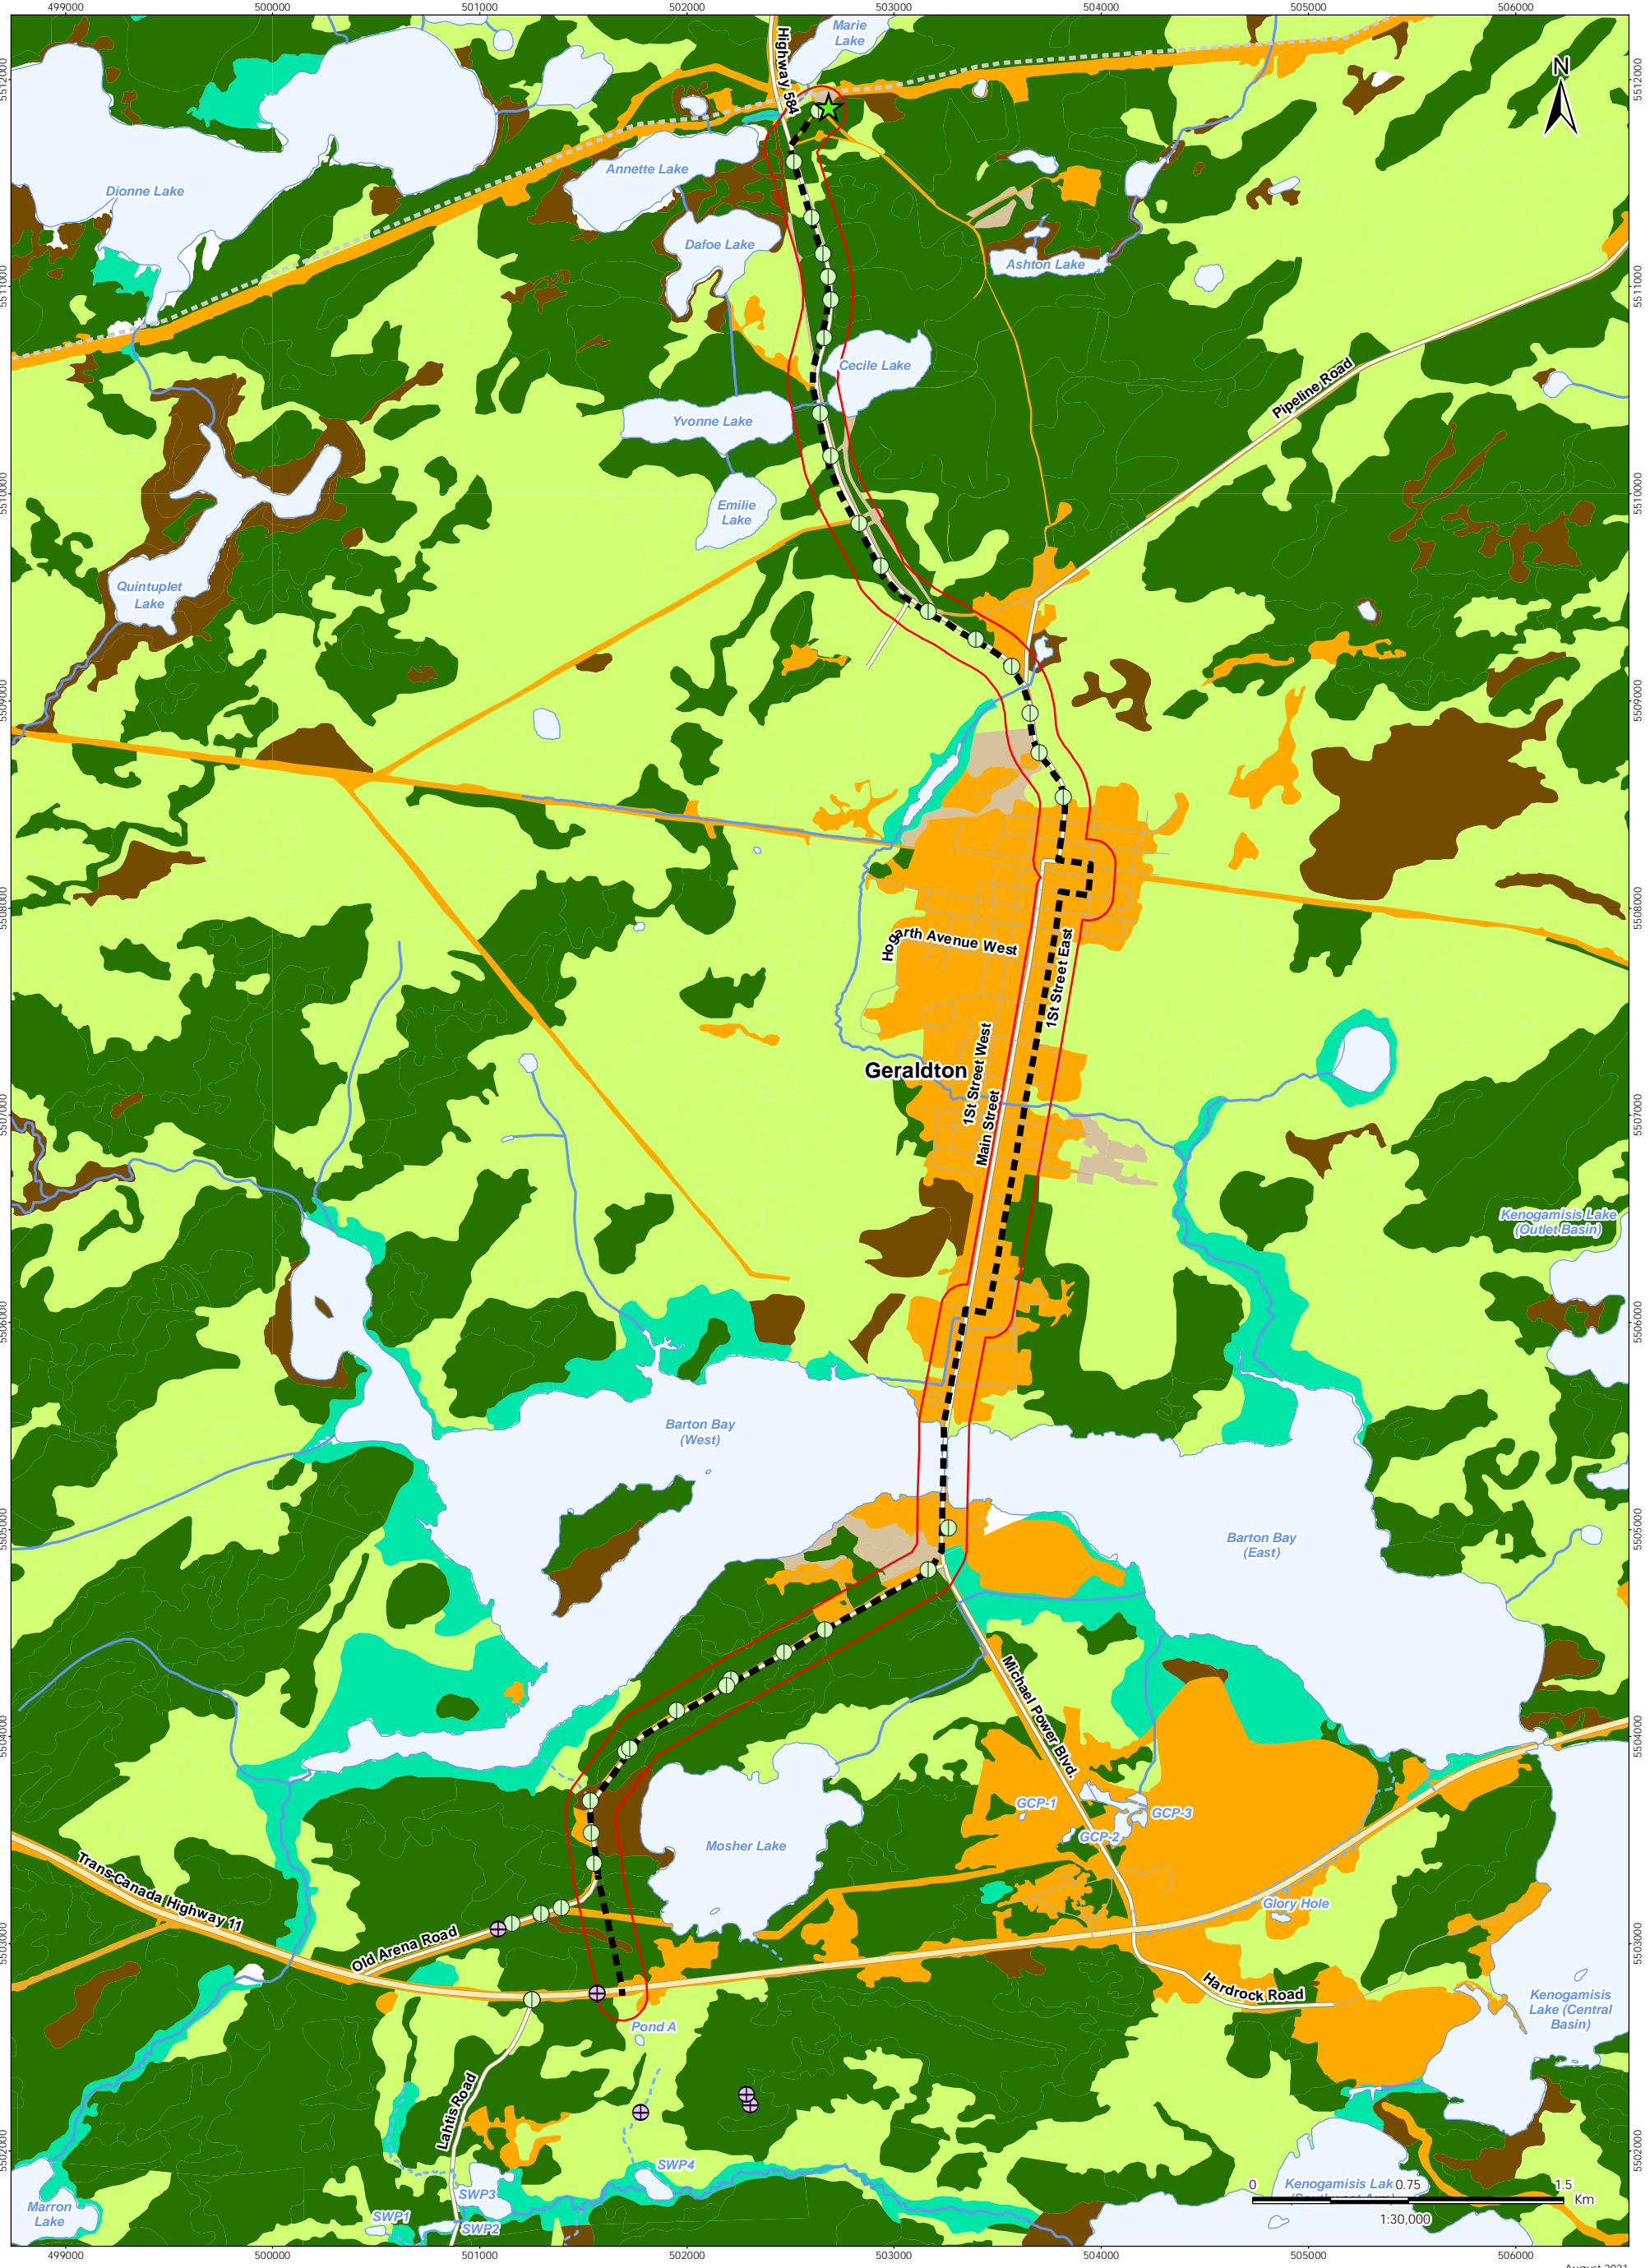
Legend <ul style="list-style-type: none"> Study Area (120 m) ★ Existing Enbridge Gas Station Amphibian Station Salamander Station Trans Canada Pipeline Preferred Route 	Upland Vegetation Communities <ul style="list-style-type: none"> Forest Meadow Wetland Vegetation Communities <ul style="list-style-type: none"> Fen Marsh Swamp 	Disturbed Vegetation Communities <ul style="list-style-type: none"> Disturbed (Includes Built Up Areas) Existing Features <ul style="list-style-type: none"> Contour Line (10m intervals) Highway Major Road Local Road 	<ul style="list-style-type: none"> Railway Watercourse-Permanent Watercourse-Intermittent Waterbody 	<p>Client/Project</p> <p>Enbridge Gas Inc. Greenstone Pipeline Project Appendix A</p> <hr/> <p>Figure No.</p> <p>A4</p> <hr/> <p>Title</p> <p>Herptile Survey Stations</p>
--	---	--	---	--

No salamander egg masses or vernal pooling suitable for salamander breeding were observed during field surveys in the Study Area.

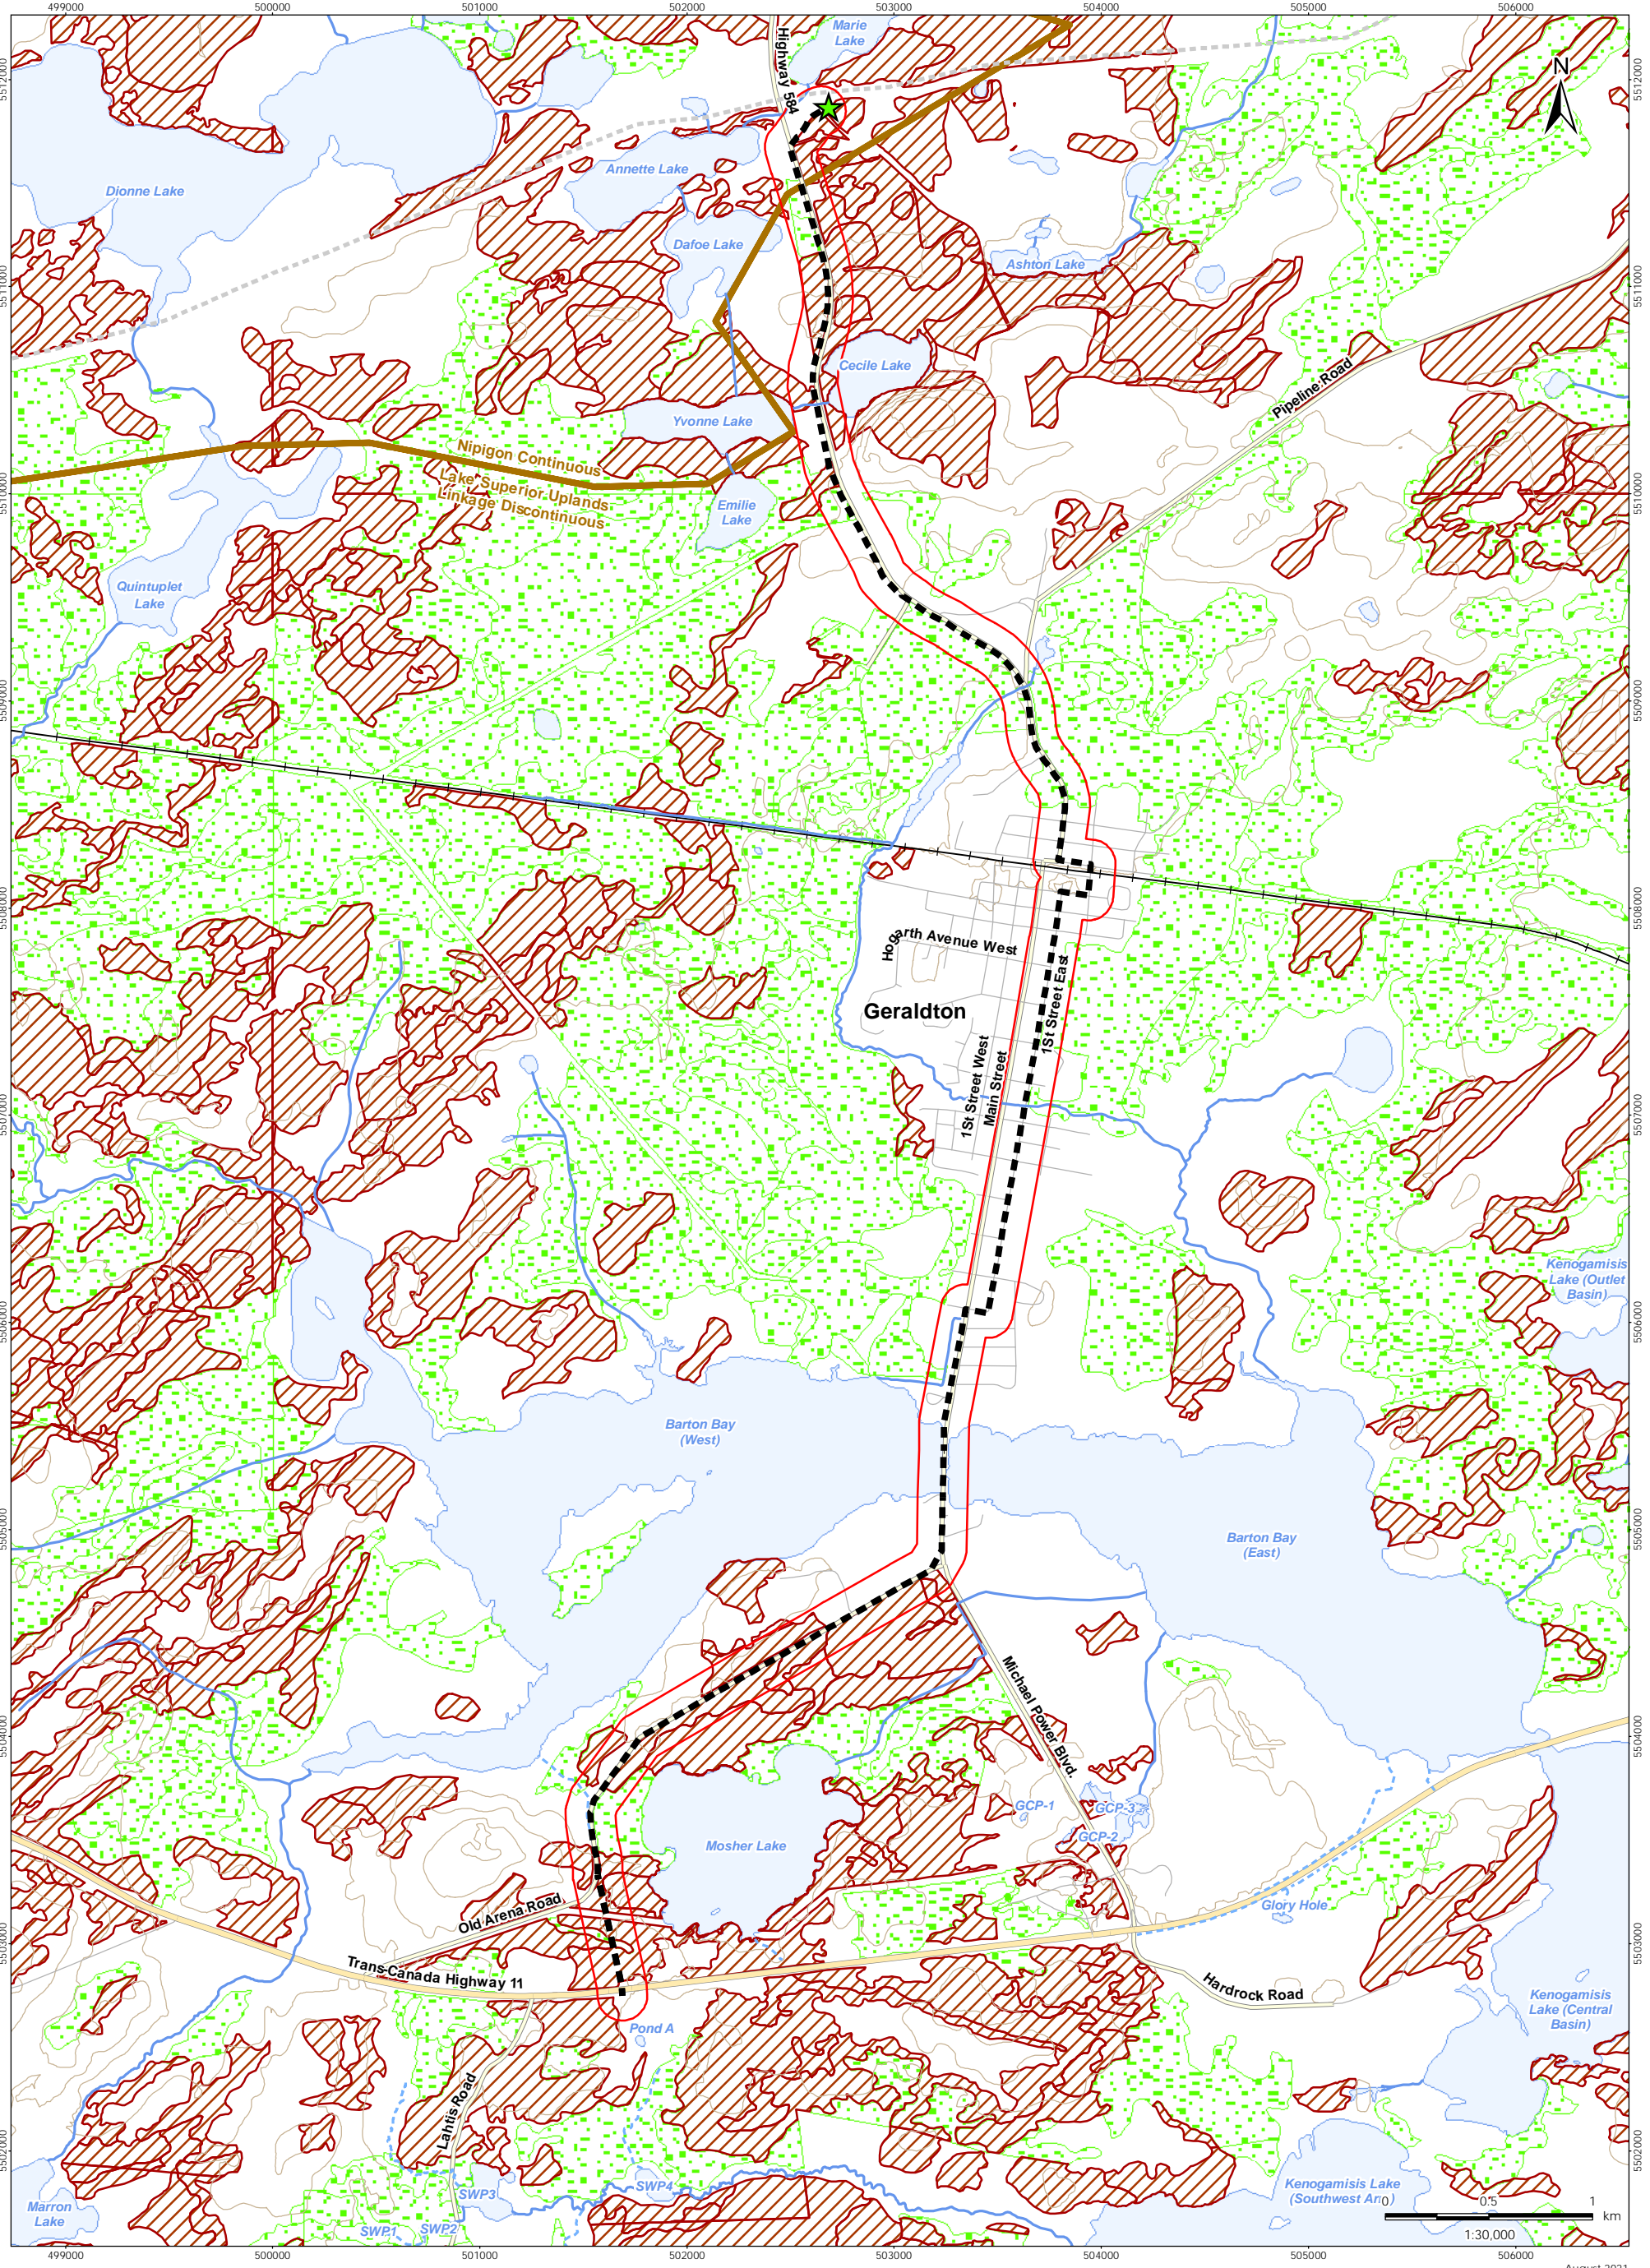
Incidental butterfly observations were recorded; however, no Taiga Alpine were observed in the Study Area. The species is known to occur within the regional area (Stantec 2017) and for the purposes of this report suitable ecosites are conservatively considered to provide potential habitat for Taiga Alpine. Potential habitat for Taiga Alpine is shown on **Figure A10, Appendix A**.

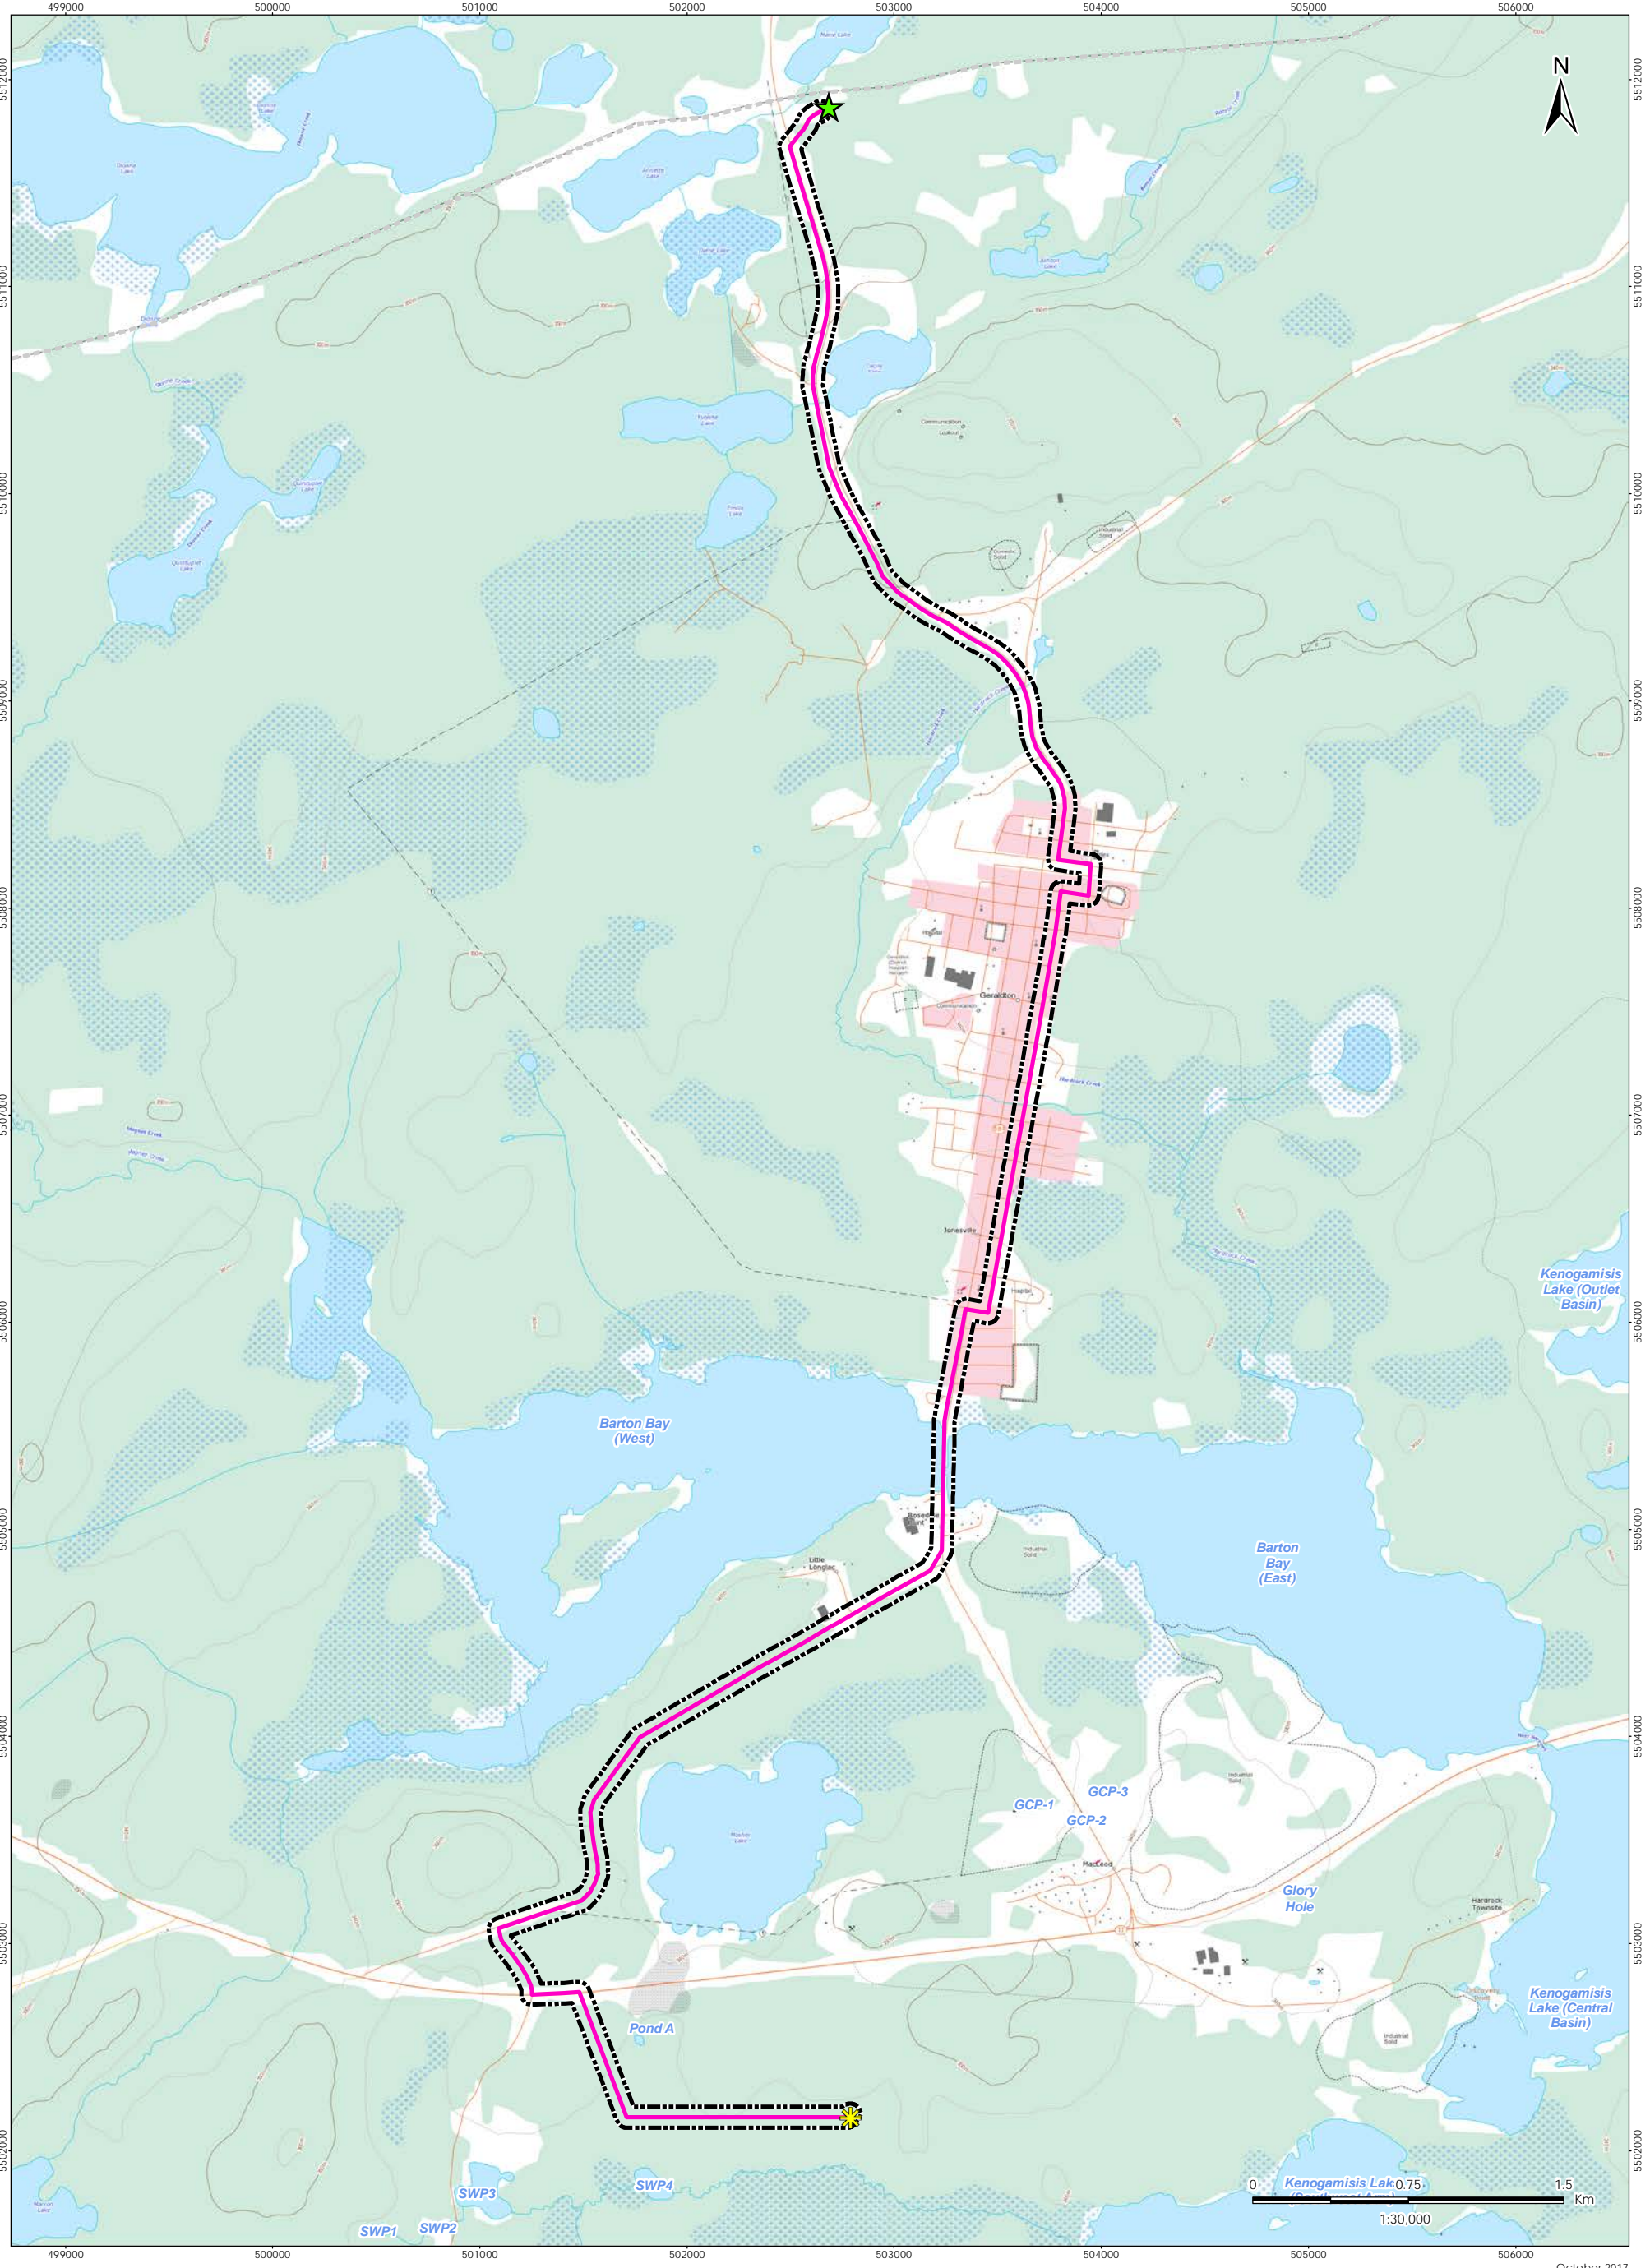
Figure No.
1

Title
Project Location

The Study Area is located in Northern Ontario, within the Municipality of Greenstone, and passes through the community of Geraldton (Figure 1). This portion of Northern Ontario was not surveyed into counties or townships with concessions and lots. As a result, the Study Area is not located within these categories of land organization.

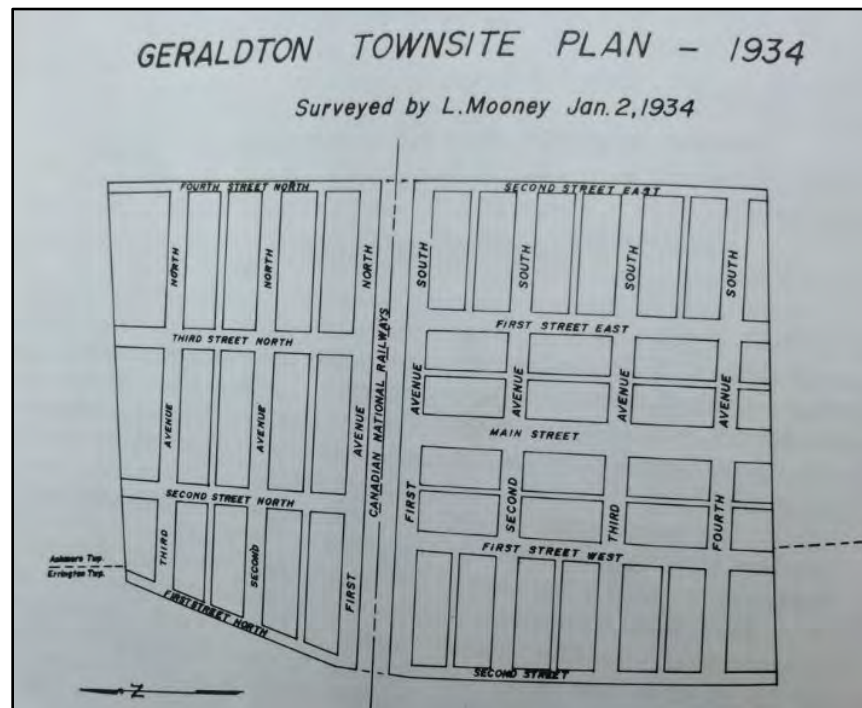
Plate 1: Geraldton Townsite Plan (Lavoie 1987: 58)

A town site was surveyed in early 1934 by Ontario land surveyor L. Mooney (Plate 1). The town was named Geraldton after S.J. Fitzgerald and J. Errington, two mining executives from the Sudbury Diamond Drilling Company. By the end of 1934 Geraldton boasted a café, general store, barber, hotel, lumber company, law office and Royal Bank Branch. Already, 200 residents lived in the town (Lavoie 1987: 64).

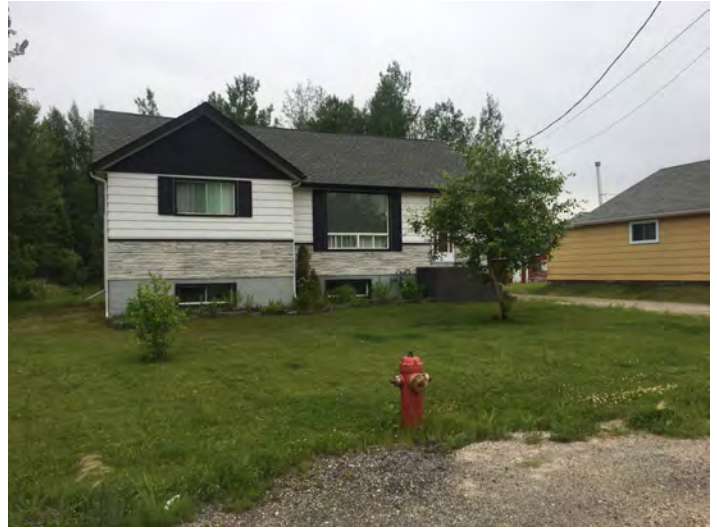
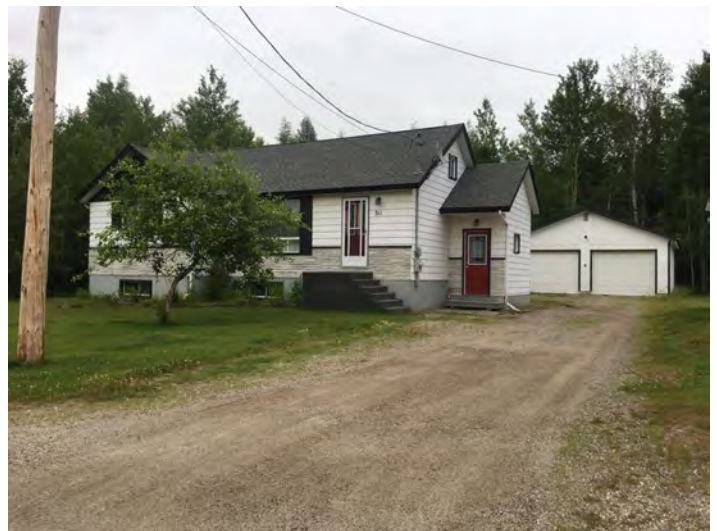
Figure
A

Description: This property contains a residence and outbuilding. The residence is a one storey structure with a loft. The roof is a medium- pitched front facing gable roof, with asphalt shingles. The exterior has modern siding and windows. The residence has an enclosed front entry porch. The residence has a concrete foundation. The rear out building has a gable roof that has a shed roof addition, horizontal wood exterior and a 1 by 1 wood window.

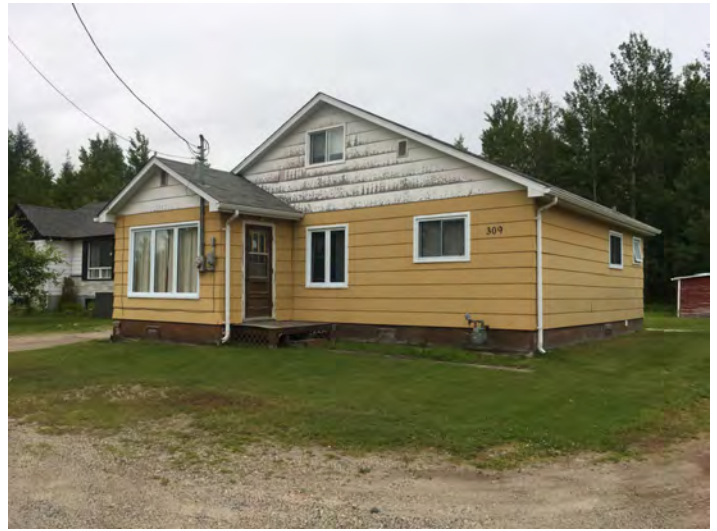
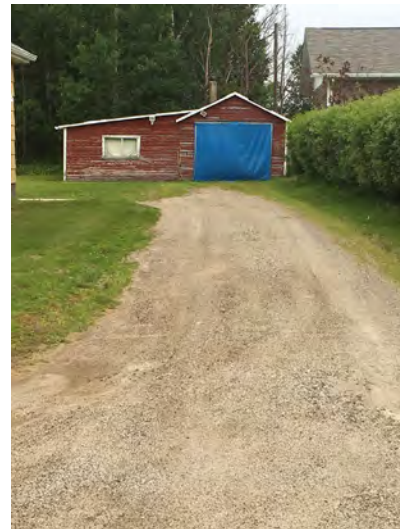
Figure
A

Description: This property contains a residence and outbuilding. The residence is a one storey structure with a low-pitched cross gable roof, with asphalt shingles. The exterior has an asymmetrical front facade, modern siding, and a concrete foundation. The outbuilding is a modern garage at the rear of the property.
