**Greenstone Pipeline Project:
Environmental Report**

FINAL REPORT

August 9, 2021

Prepared for:
Enbridge Gas Inc.
50 Keil Drive
Chatham ON N7M 5M1

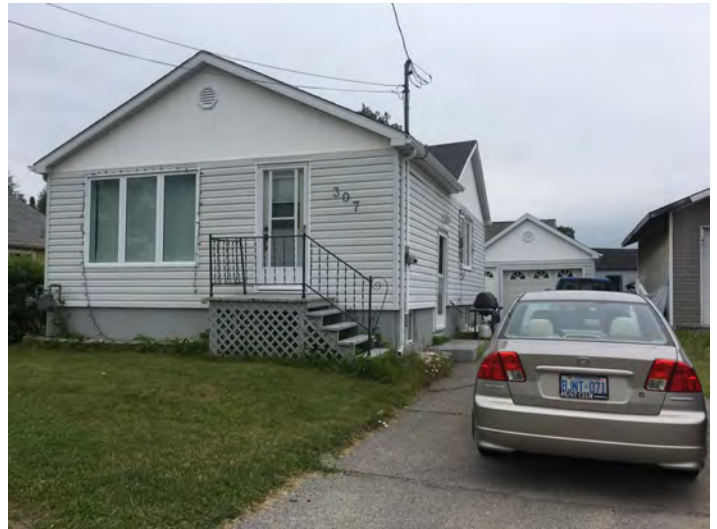
Figure
A

Description: This property contains a residence and outbuilding. The residence is a one storey structure with a loft. The roof is a medium- pitched front facing gable roof, with asphalt shingles, and a brick chimney. The exterior has a symmetrical front facade, concrete asbestos siding and modern windows. The residence has a shed roof addition and a concrete foundation. The outbuilding is a one storey structure with a gable roof, asphalt shingles, and 8 paned fixed wood window.

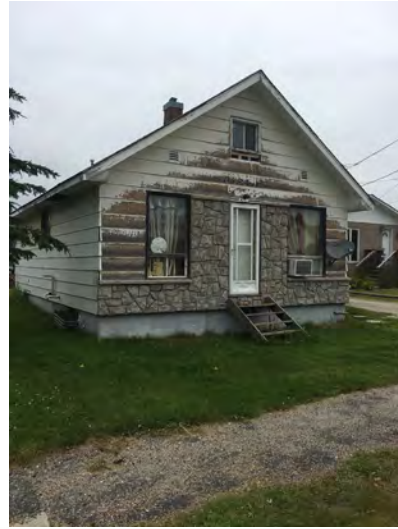
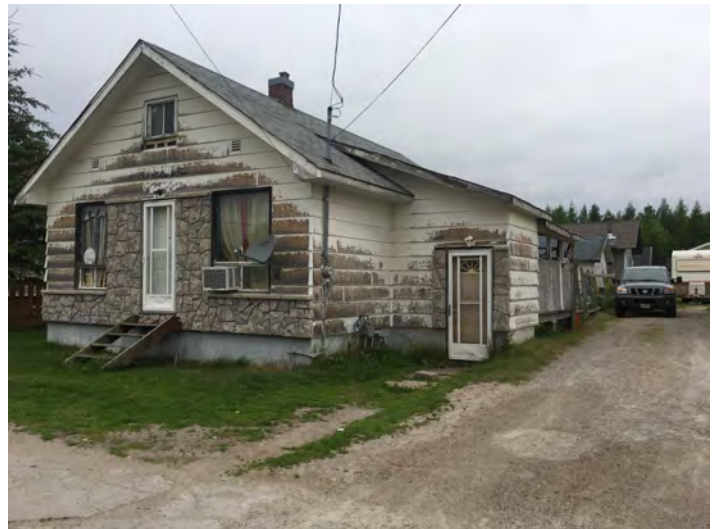
Figure
A

Description: This property contains a residence and modern outbuilding. The residence is a one and a half storey structure with a front facing gable roof that has asphalt shingles. The exterior is clad with modern siding, and has modern windows. The front elevation has an enclosed front entry porch, and partial wooden porch. The residence has a concrete foundation.

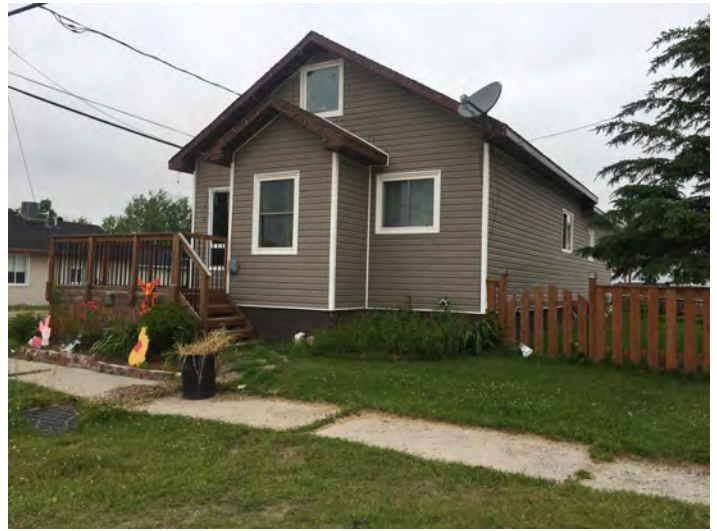
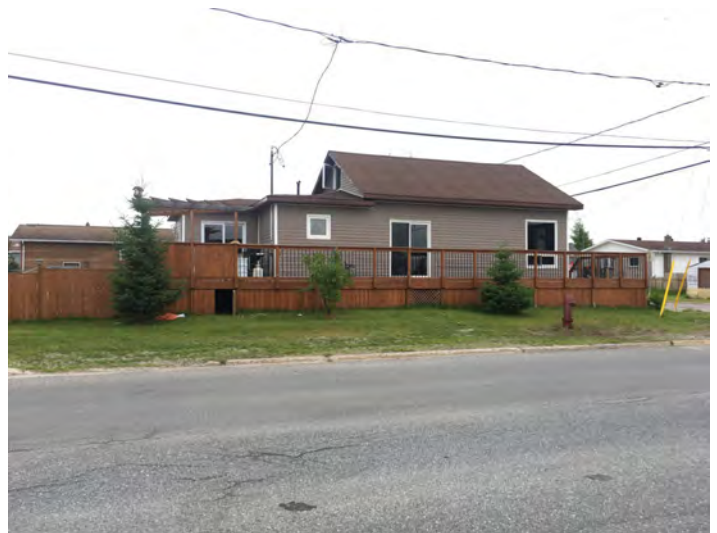
Figure
A

Description: This property contains a residence and a modern outbuilding. The residence is a one storey structure with a low-pitched front facing gable with rear hipped roof and shed roof end. The roof has asphalt shingles. The exterior has concrete asbestos siding and modern windows, and a concrete foundation. The property is surrounded by a wood picket fence.

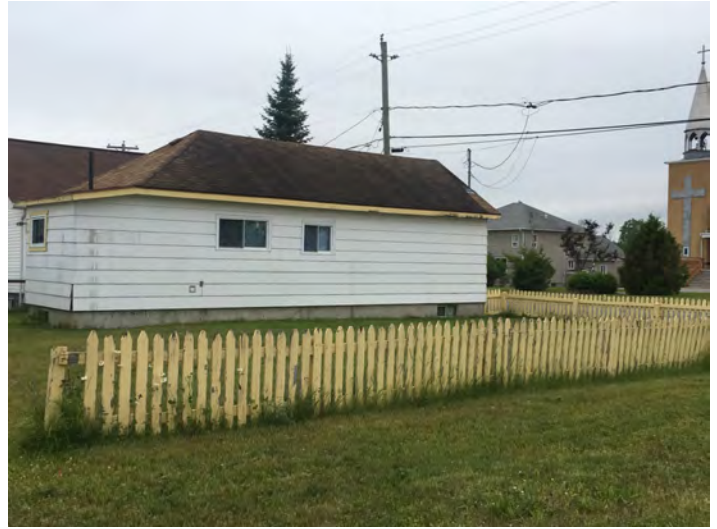
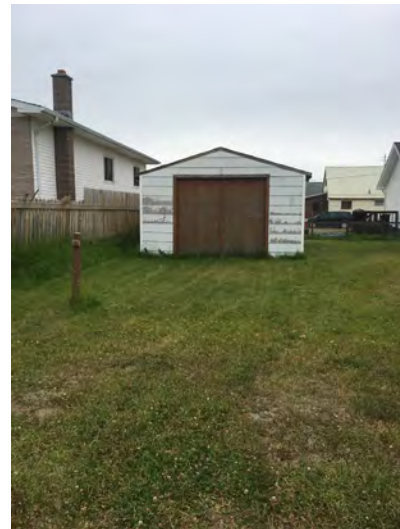
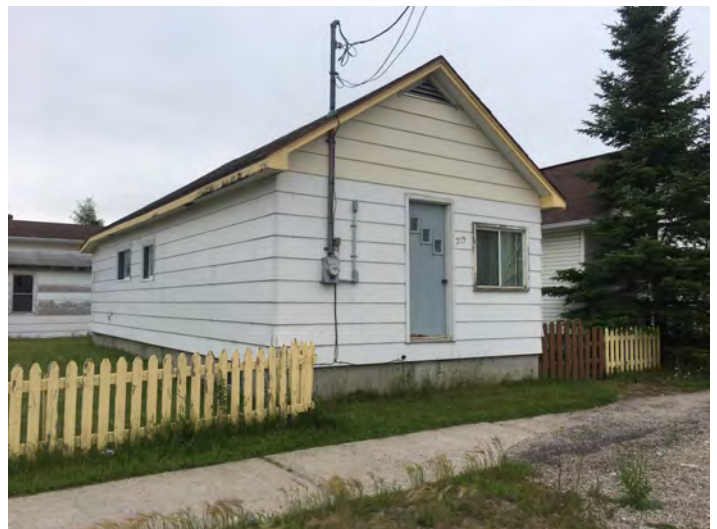
Figure
A

Description: This property contains a residence. The residence is a one storey structure with a low-pitched front facing gable roof with asphalt shingles and concrete block chimney. The exterior has modern siding, partial wood entry porch, an asymmetrical front facade, and concrete foundation.

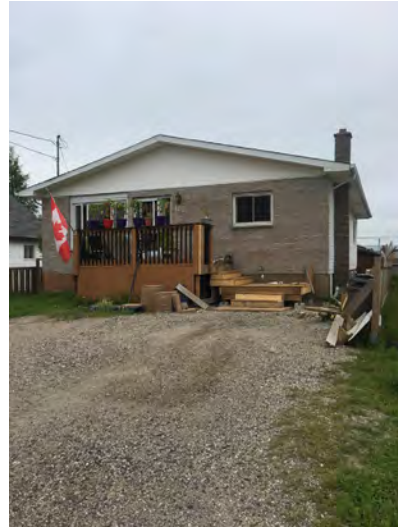
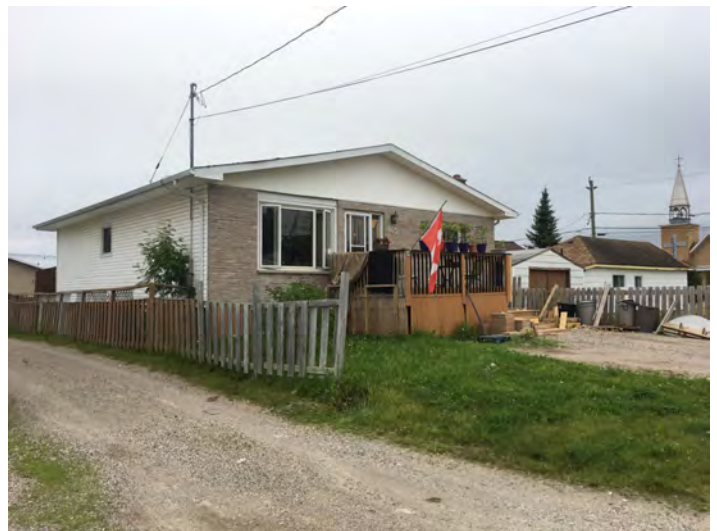
Figure
A

Description: This property contains a residence and outbuilding. The residence is a one storey structure with a front facing gable roof, with a shed roof addition, and asphalt shingles. The exterior has modern siding and windows, and a concrete foundation. The outbuilding is a one storey structure with a gable roof. The exterior of the outbuilding has modern siding, and a concrete foundation.

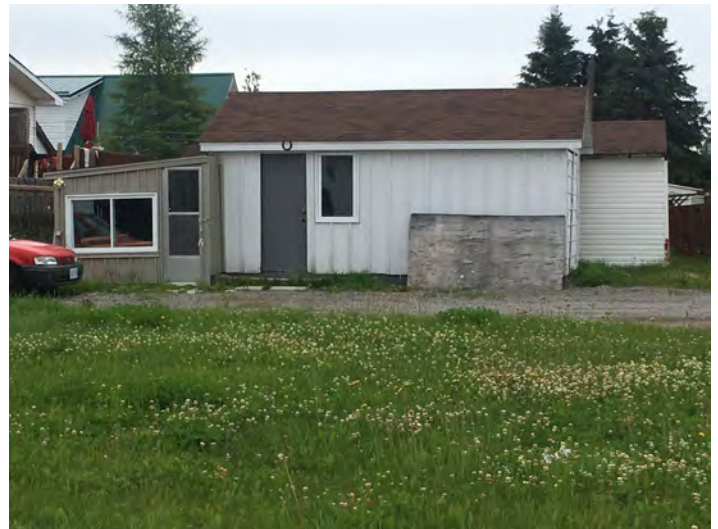
Figure
A

Description: This property contains a residence and outbuilding. The residence is a one storey structure with a low-pitched front facing gable roof that has asphalt shingles. The exterior has modern siding and windows, a projecting enclosed entry porch, and modern siding over foundation. The outbuilding is a modern one car garage with front facing gable roof.

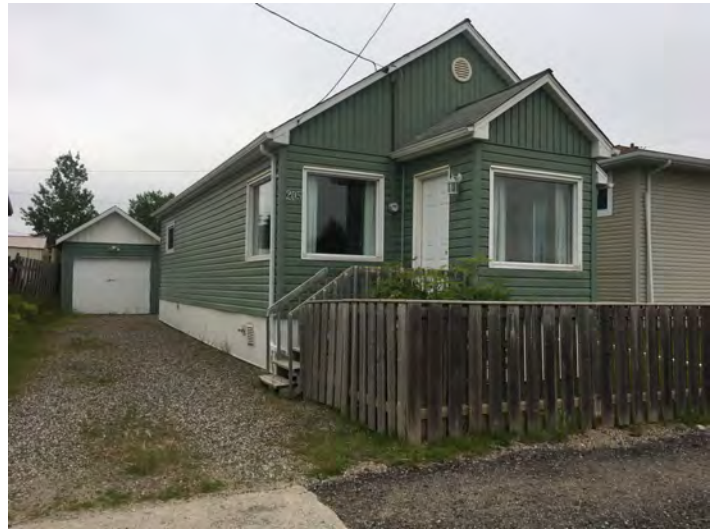
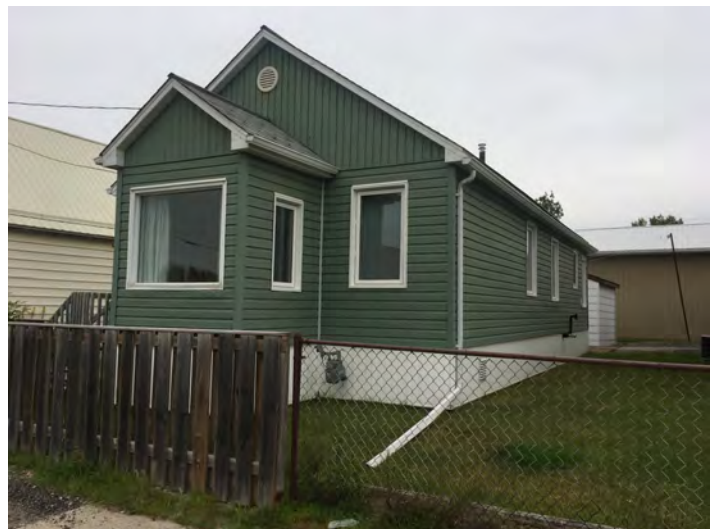
Figure
A

Description: This property contains a residence. The residence is a one storey building with a front facing gable roof that is clad in metal. The exterior has modern siding and windows, a partial entry porch, and modern siding over its foundation.

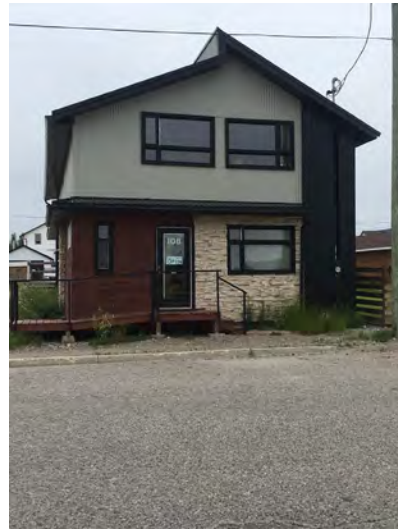
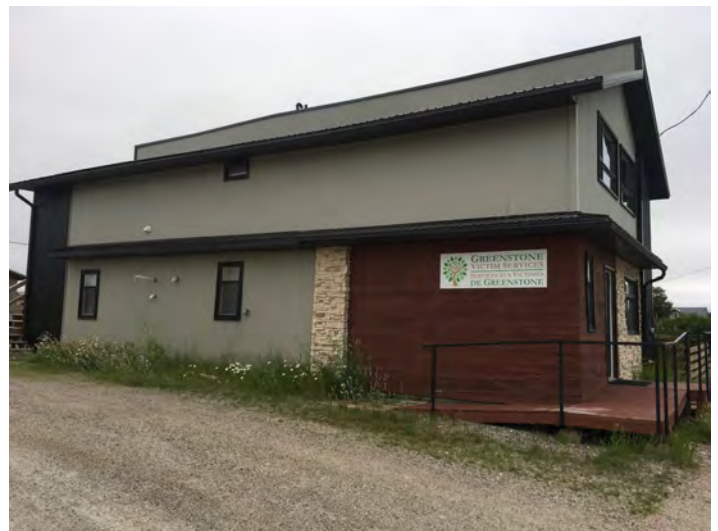
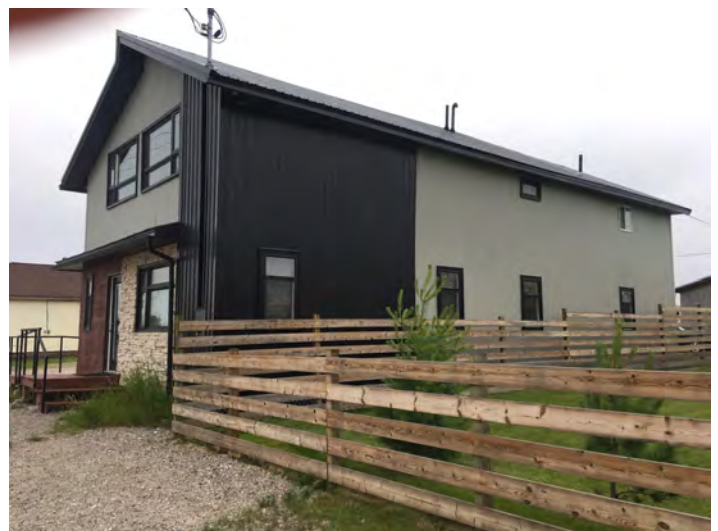
Figure
A

Description: This property contains a commercial building. The building is occupied by Greenstone Victim Services. The building is a one and a half storey structure with an irregular front facing gable roof with modern design. The exterior has been heavily altered, and has modern siding and windows. The building has an asymmetrical front entrance, partial entry porch, and a concrete foundation. The structure was recently renovated.

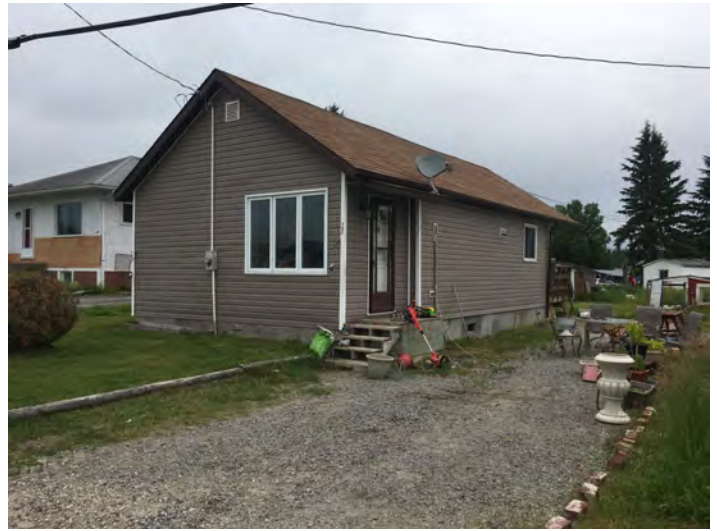
Figure
A

Description: This property contains a residence. The residence is a one storey structure with a low-pitched front facing gable roof that has asphalt shingles. The asymmetrical exterior has modern siding, modern windows, and a concrete foundation.

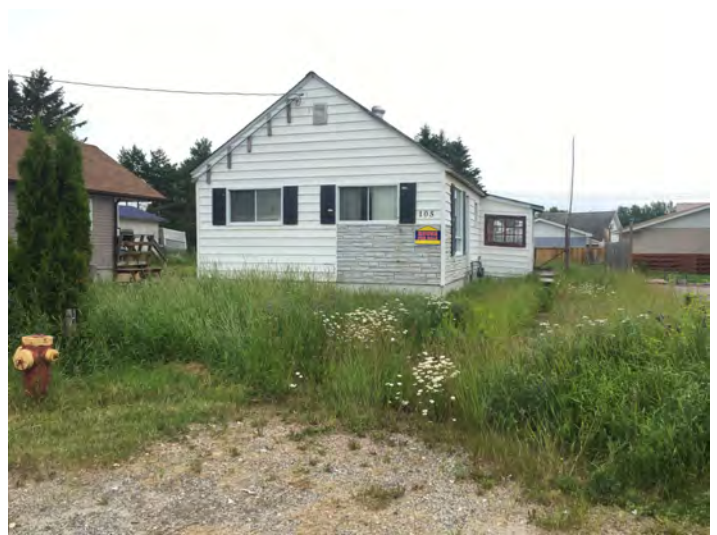
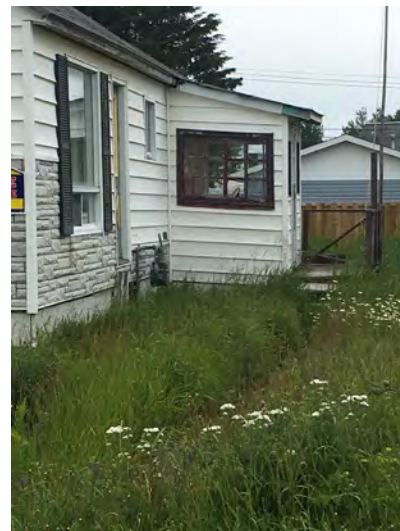
Figure
A

Description: This property contains a residence. The residence is a one storey structure with a medium-pitched front facing gable roof with asphalt shingles. The exterior has modern siding, partial decorative stonework, and a concrete foundation. The residence has a shed roof addition with 6 by 6 wood windows.

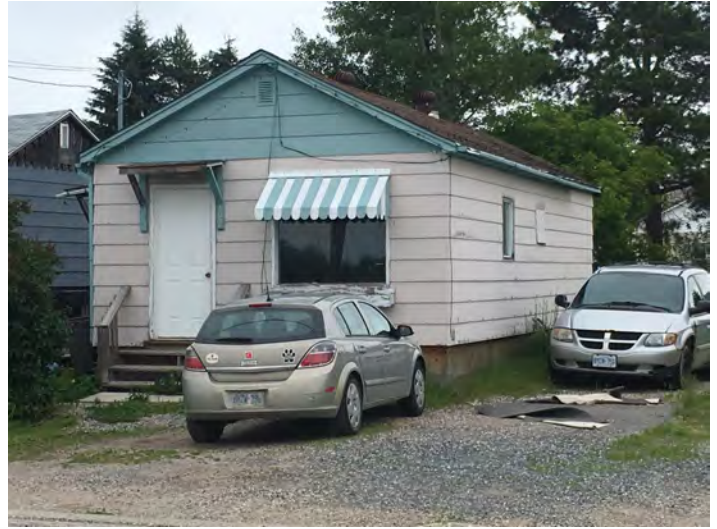
Figure
A

Description: This property contains a residence. The residence is a one storey structure with a low-pitched front facing gable roof. The exterior has concrete asbestos siding, modern windows, and partial wooden entry porch. The foundation is covered in wood.

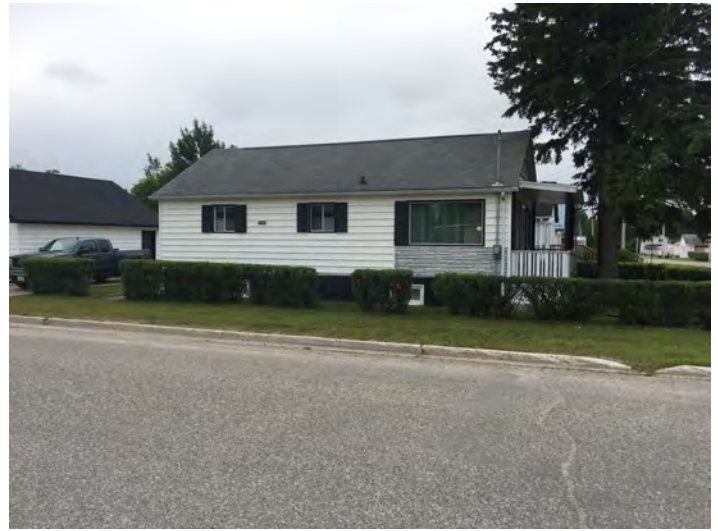
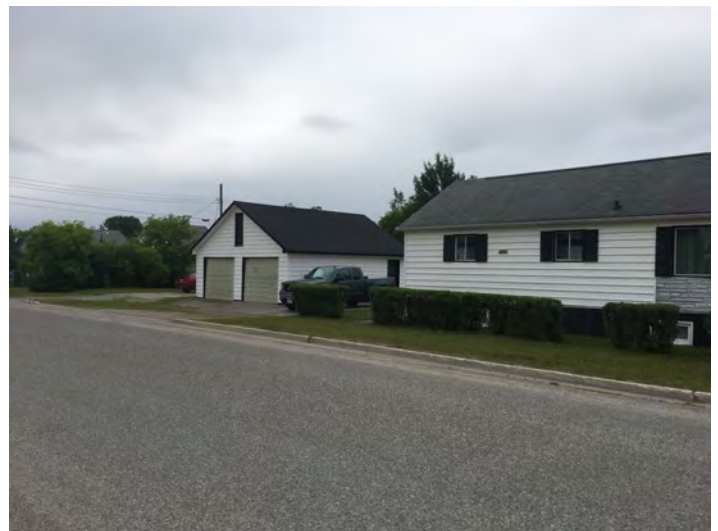
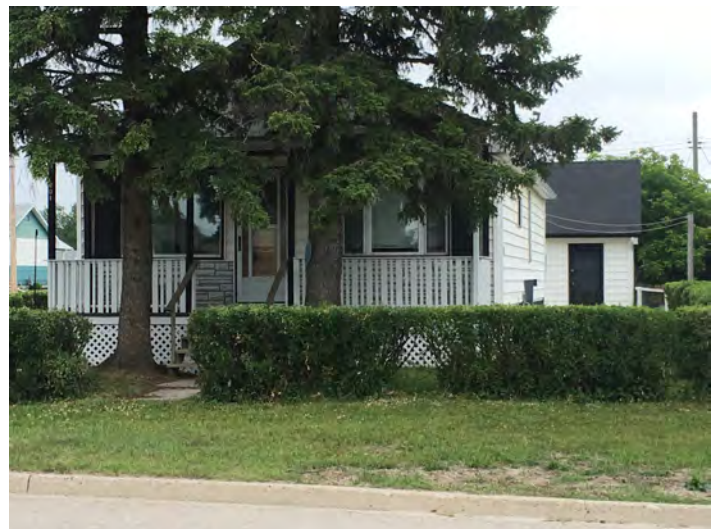
Figure
A

Description: This property contains a residence and outbuilding. The residence is a one storey structure with a medium-pitch front facing gable roof with asphalt shingles. The exterior has modern siding and windows. The symmetrical front elevation has a full front wood porch. The residence has a concrete foundation. The outbuilding is a two car garage with a steeply-pitched front facing gable roof. The property has mature spruce trees and partial hedgerow.

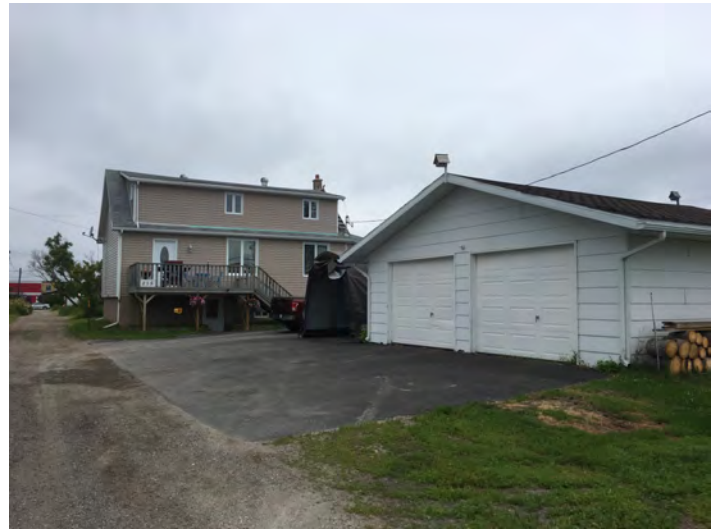
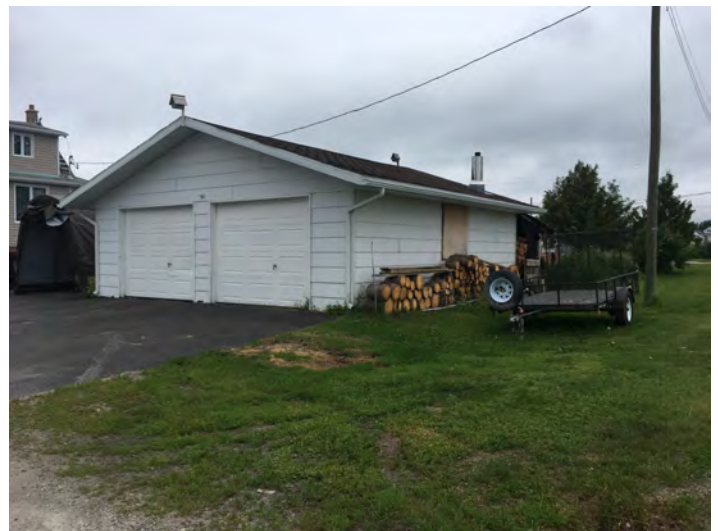
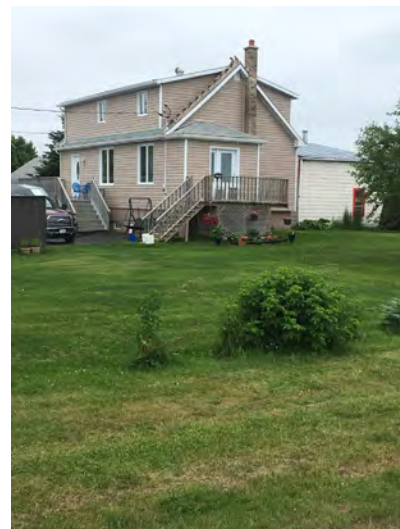
Figure
A

Description: This property contains a residence and outbuilding. The residence is a one and a half storey structure with a gable roof with large shed roof dormer, brick chimney, and asphalt shingles. The exterior has modern siding, modern windows, a partial wood entry porch, and concrete foundation with basement. The outbuilding is a modern two car garage with a gable roof.

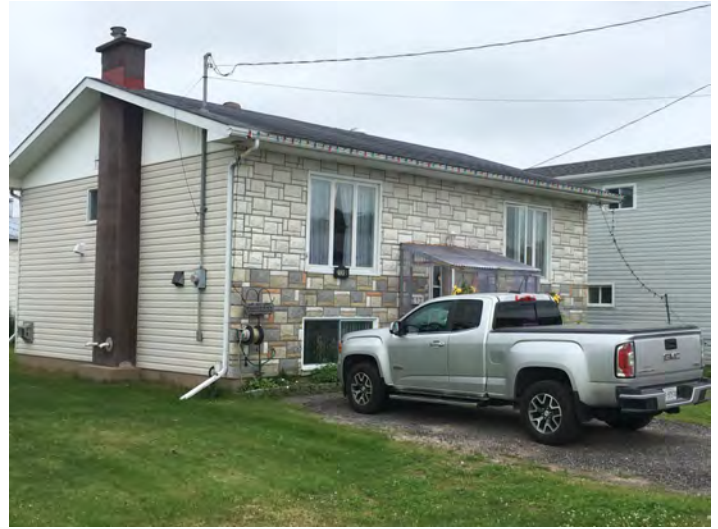
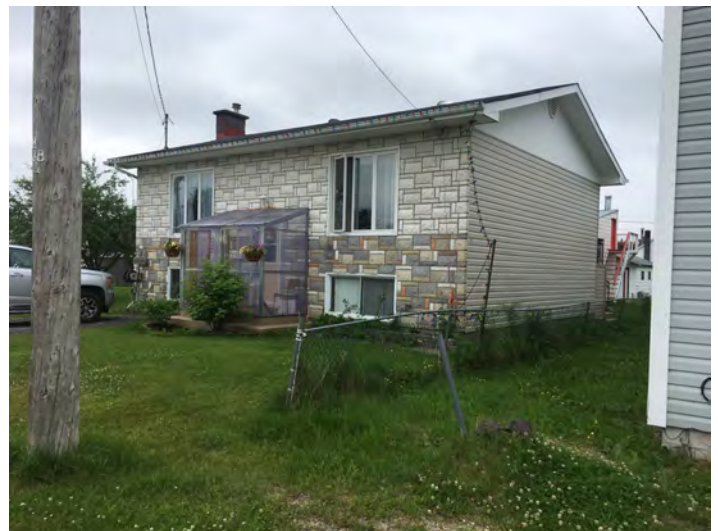
Figure
A

Description: This property contains a residence. The residence is a one storey structure with a medium-pitched side gable roof that has asphalt shingles, and a concrete block chimney. The exterior has modern siding, modern windows, a and concrete foundation. The front elevation is symmetrical.

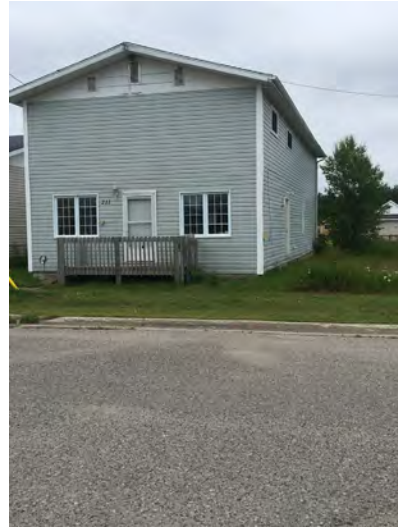
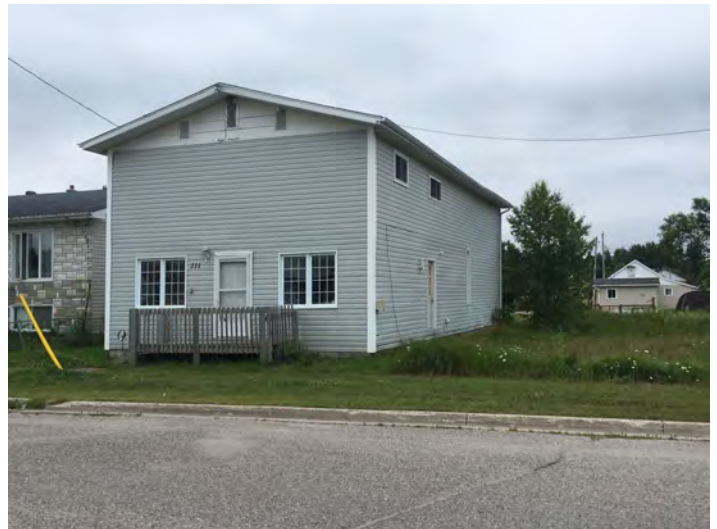
Figure
A

Description: This property contains a residence. The residence is a two storey structure with a low-pitched front facing gable roof. The exterior has modern siding and modern windows, and concrete foundation. The front elevation is symmetrical.

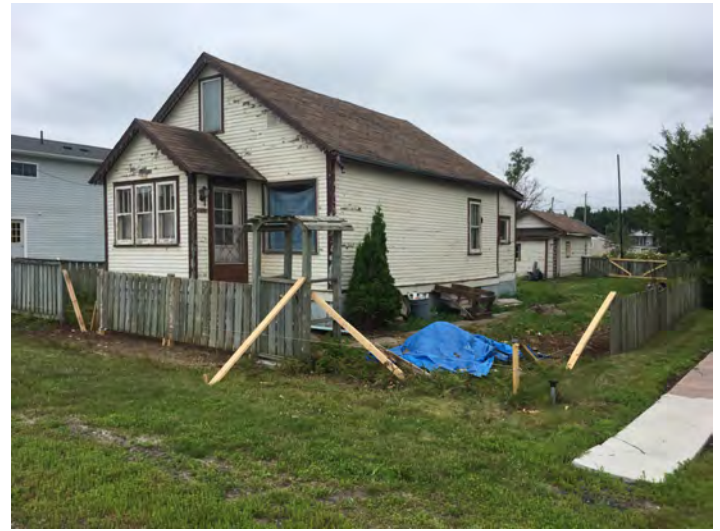
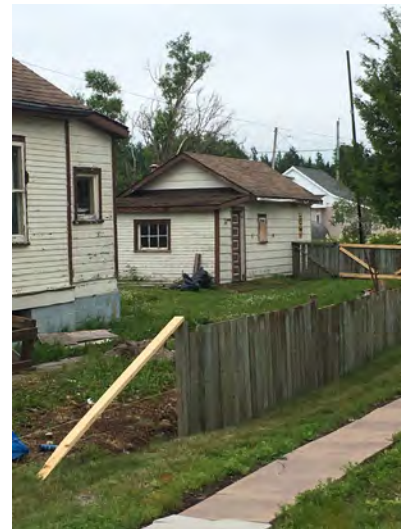
Figure
A

Description: This property contains a residence and outbuilding. The residence is a one storey structure with a front facing gable roof that has asphalt shingles. The front elevation has a projecting entrance porch and a front facing gable with wood tracery. The exterior has horizontal wood siding, with 3/1 wood windows, and a concrete block foundation. The outbuilding has a side gable roof, modern siding, and an attached shed roof addition with horizontal wood siding and a fixed 6 pane window. The property is partially surrounded by wood fence.

Design or Physical Value: This structure is representative of the first types of residences constructed in Geraldton. It is a rare example of a structure from this period with largely original features.

Contextual Value: Representative of buildings from the founding period of Geraldton.

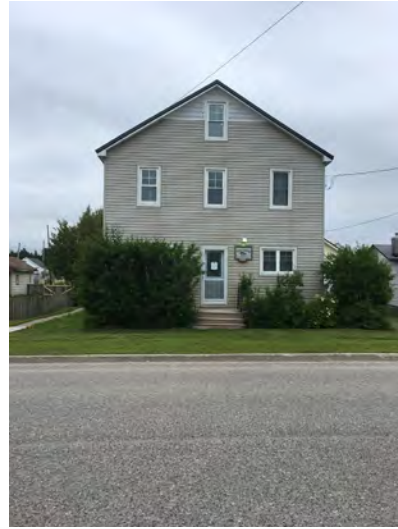
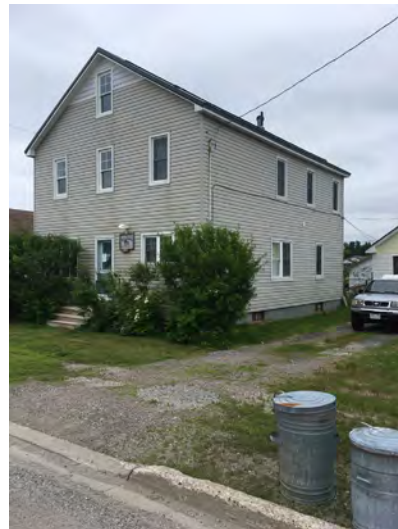
Figure
A

Description: This property contains a residence converted into a commercial building, The building is occupied by the Victoria Bed and Breakfast. The commercial building is a two and a half storey structure with a low-pitched front facing gable roof clad in metal. The front elevation is symmetrical with decorative shingles in its gable peak. The exterior has modern siding and windows, and concrete foundation with basement.

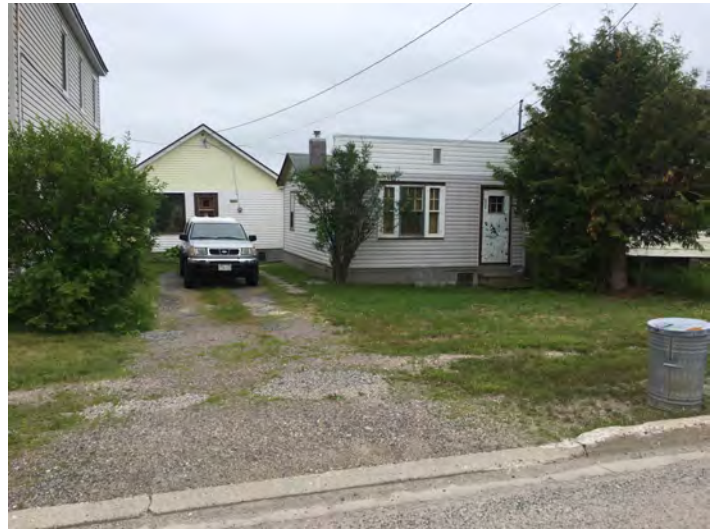
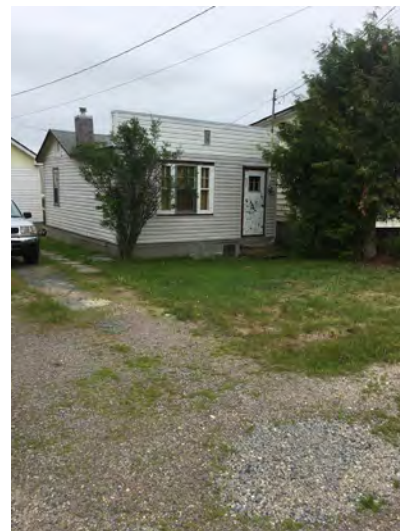
Figure
A

Description: The property contains two residences. The rear residence is a one storey structure with a steeply-pitched front facing gable roof. The exterior has modern siding, modern windows, and wood over its foundation. The front residence is a one storey structure with a low-pitched cross gable roof, with front parapet and brick chimney. The exterior has modern siding, modern windows, and wood over its foundation.

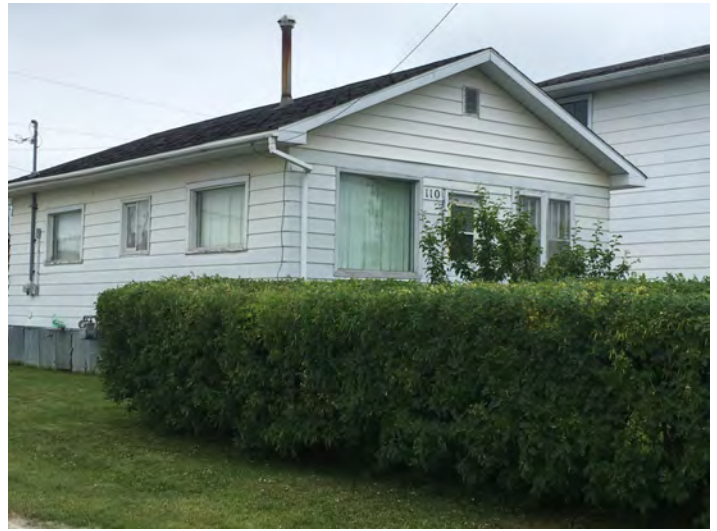
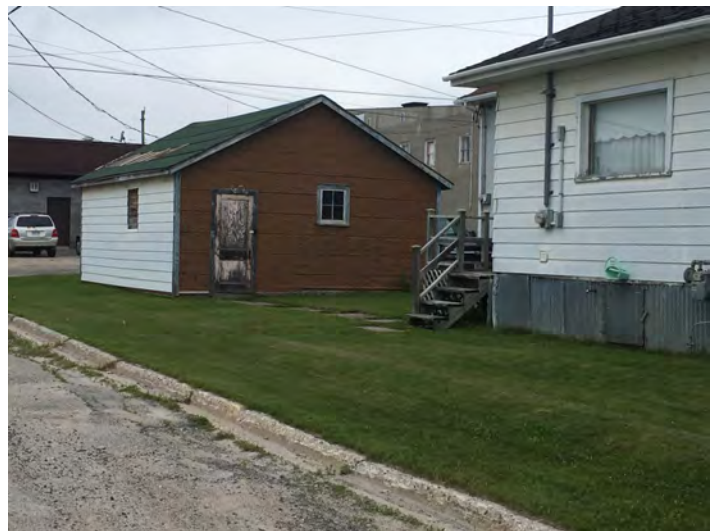
Figure
A

Description: This property contains a residence and outbuilding. The residence is one storey, with a low-pitched front facing gable roof that has asphalt shingles. The exterior has concrete asbestos siding, 3/1 wood windows on one side of front facade, modern windows, wood window surrounds, and metal over its foundation. The rear outbuilding has a medium-pitched gable roof with modern siding and a four pane wood window.

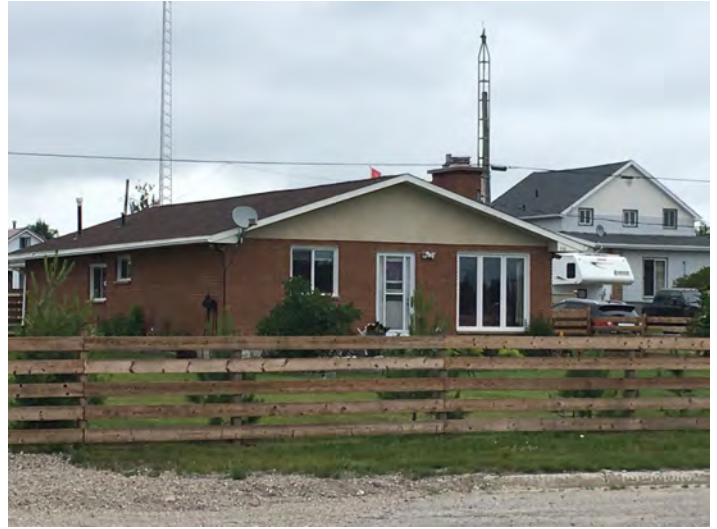
Figure
A

Description: This property contains a residence. The residence is a one storey structure with a low-pitched front facing gable roof and brick chimney. The exterior is clad in brick, has modern windows, and a concrete foundation. The property is surrounded in modern wood fencing.

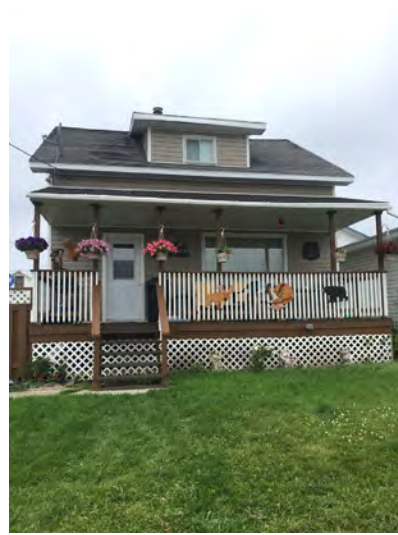
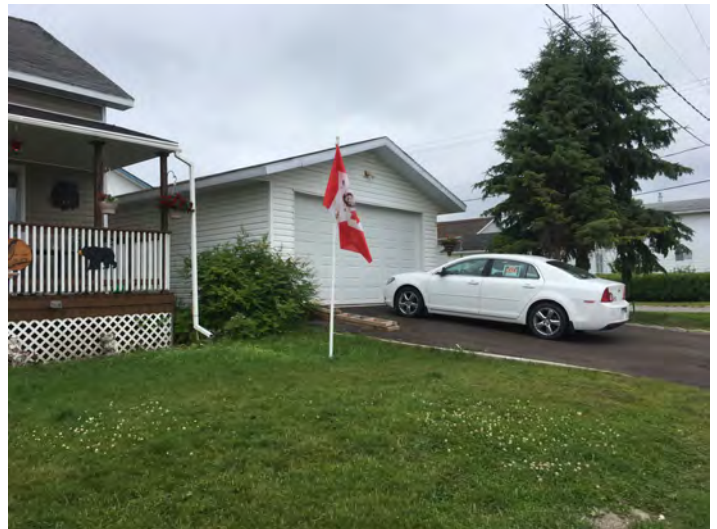
Figure
A

Description: This property contains a residence and outbuilding. The residence is a one and a half storey structure with a medium- pitched side gable roof that has asphalt shingles. The front elevation has a shed dormer, and a full covered porch. The exterior has modern siding and windows, and an undetermined foundation. The outbuilding is a modern single car garage with a low-pitched front facing gable roof.

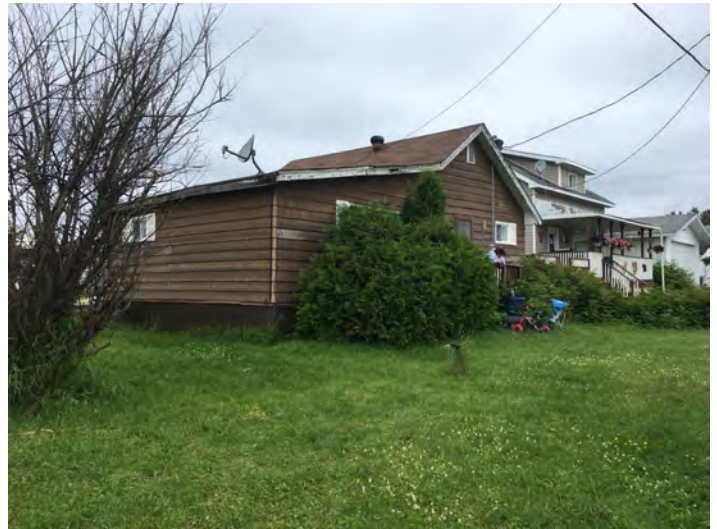
Figure
A

Description: This property contains a residence. The residence is a one storey structure with a low-pitched gable roof, with shed roof addition. The exterior has modern siding, an asymmetrical facade, and metal over its foundation.

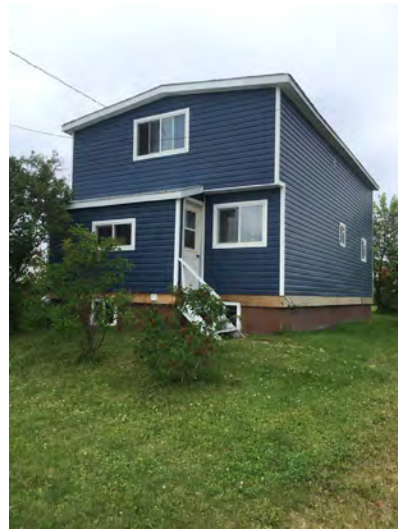
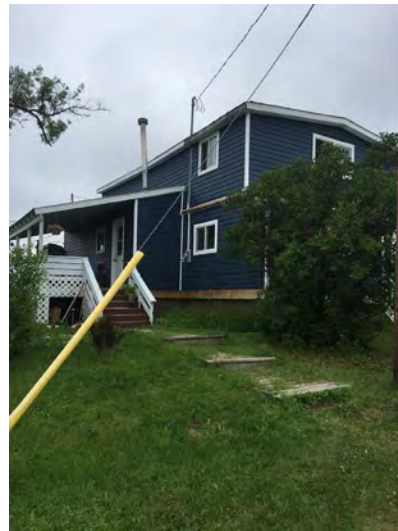
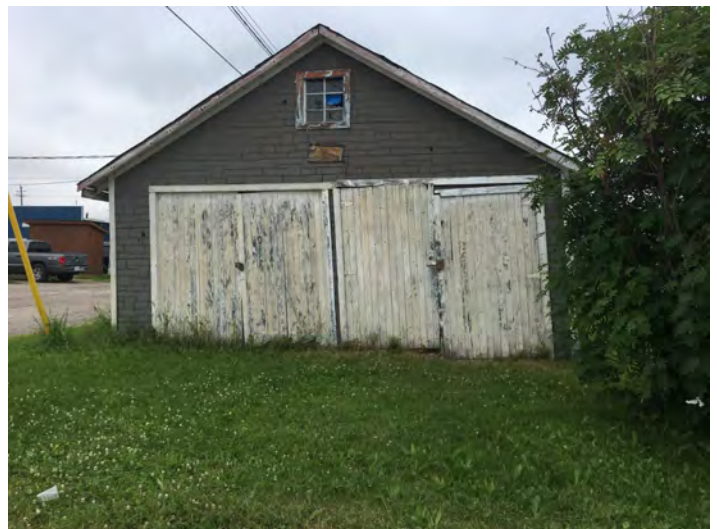
Figure
A

Description: This property contains a residence and outbuilding. The residence is a one and a half storey structure with a low-pitched gable roof. The structure has an enclosed shed roof entrance porch and south side shed roof entrance porch. The exterior has modern siding, and a concrete foundation. The rear outbuilding has a metal clad roof, modern siding, wood doors, an 8 pane fixed window, and a 6 pane fixed window.

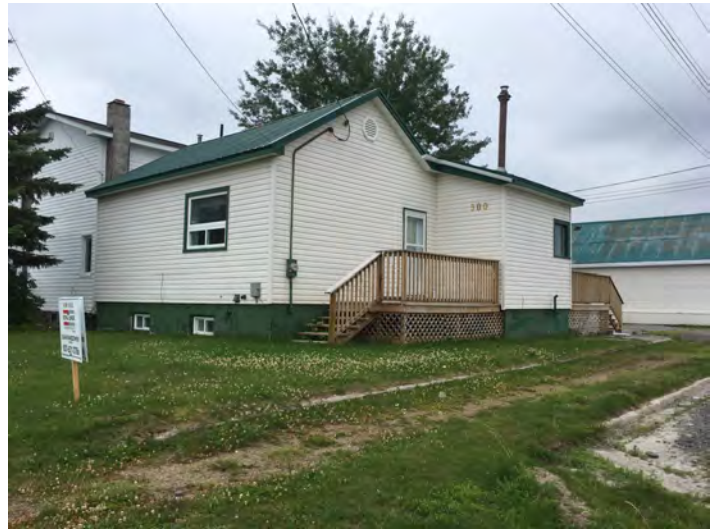
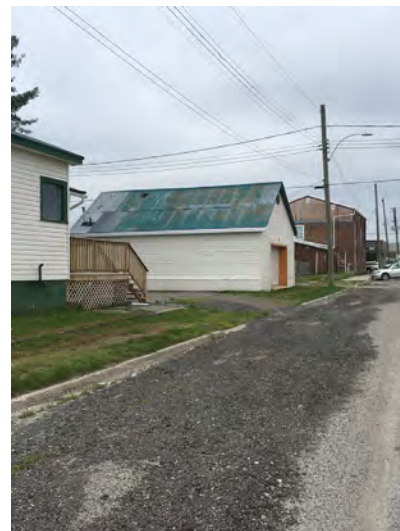
Figure
A

Description: This property contains a residence and outbuilding. The residence is a one storey structure with a medium-pitched side gable roof clad in metal. The building has a shed roof addition. The exterior has modern siding, modern windows, a partial wood entrance porch, an asymmetrical exterior, and concrete foundation. The outbuilding is a modern garage with a front facing gable roof and modern siding.

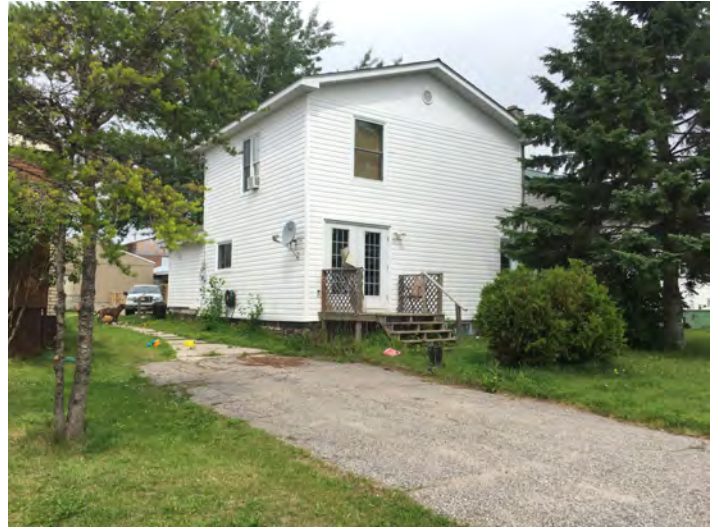
Figure
A

Description: This property contains a residence. The residence is a two storey structure with a low-pitched front facing gable roof with asphalt shingles. The exterior has modern siding, an asymmetrical exterior, and a rusticated concrete foundation.

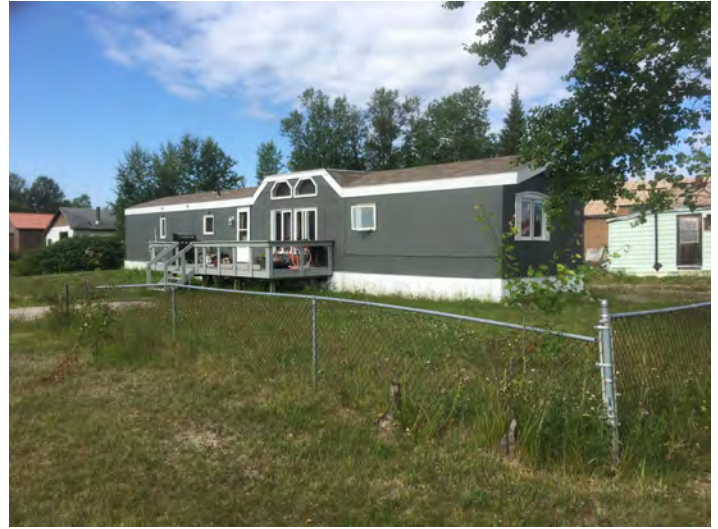
Description: This property contains a residence. The structure is possibly two attached modular home components. The residence is a one storey structure with a low-pitched hip roof with asphalt shingles. The exterior has modern siding and windows, a partial wood entrance porch on east elevation, and siding over its foundation.

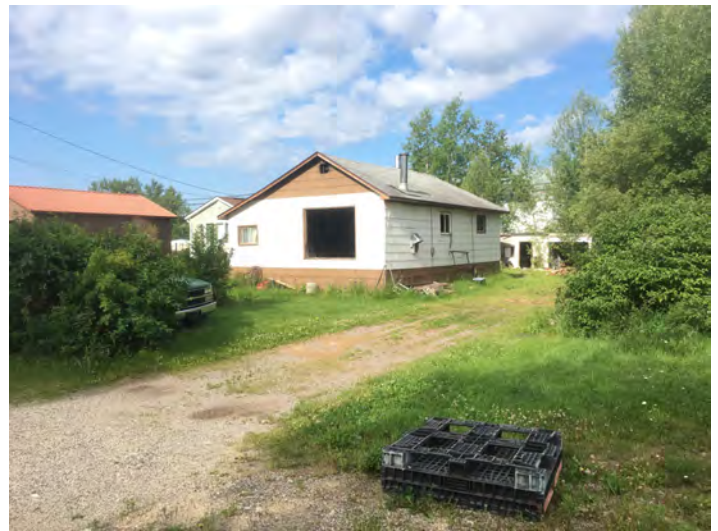
Description: This property contains a residence and outbuilding. The residence is a one storey structure with a medium-pitched cross gable roof with asphalt shingles. The exterior has modern siding and windows and an undetermined foundation. The residence appears abandoned. The outbuilding at rear of property is partially collapsed.

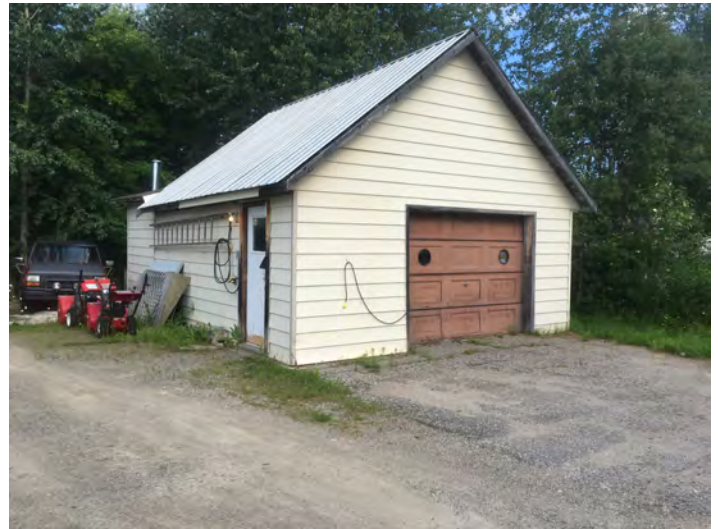
Description: This property contains a residence and outbuilding. The residence is a one storey structure with a medium-pitched cross gable roof with asphalt shingles and a concrete block chimney. The residence has a projecting hip on gable entrance on its south elevation. The exterior has concrete asbestos siding, wood window surrounds, and a concrete foundation. The outbuilding is a single car garage at rear of property.

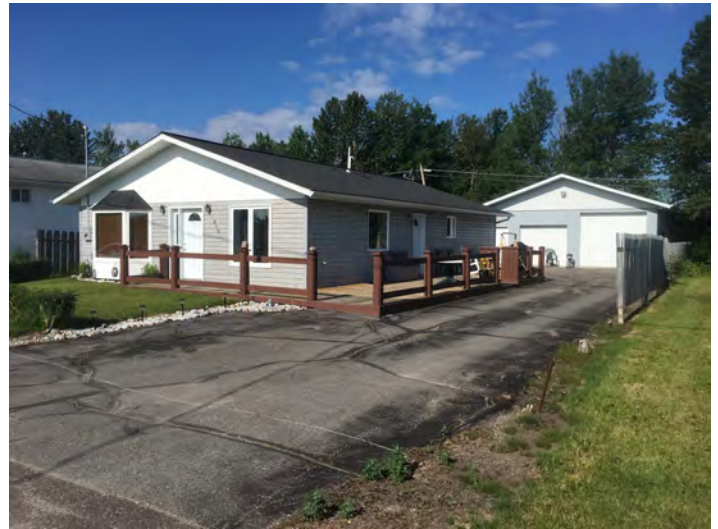
Description: This property contains a residence and outbuilding. The residence is a one storey structure with a low-pitched front facing gable roof with asphalt shingles. The exterior has modern siding and windows, and a modern bay window. The residence has a wrap-around wood porch on its east and north elevations, and an undetermined foundation. The outbuilding is a modern two car garage at rear of property.

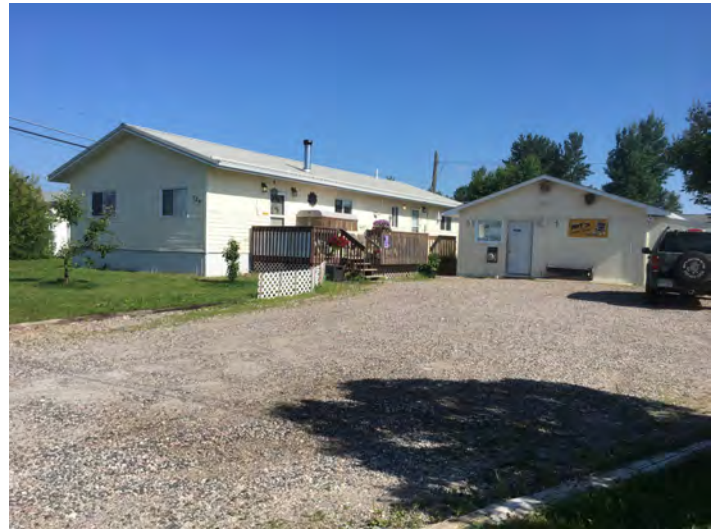
Description: This property contains a residence and outbuilding. The residence is a one storey structure with a medium-pitched gable roof clad in metal. The exterior has modern siding and windows, a partial wood entrance porch on the east elevation, and siding over its foundation. The outbuilding is a garage used for commercial purposes under the name 'Roy's Custom Repair.'

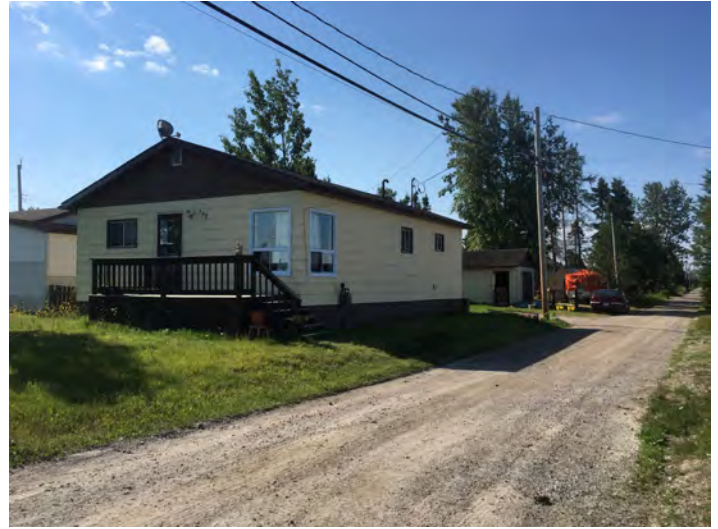
Description: This property contains a residence and outbuilding. The residence is a one storey structure with a medium-pitched front facing gable roof with asphalt shingles. The exterior has concrete asbestos siding, a partial wood front entrance porch, modern windows, and a concrete block foundation. The outbuilding is a modern garage located in the rear of the property.

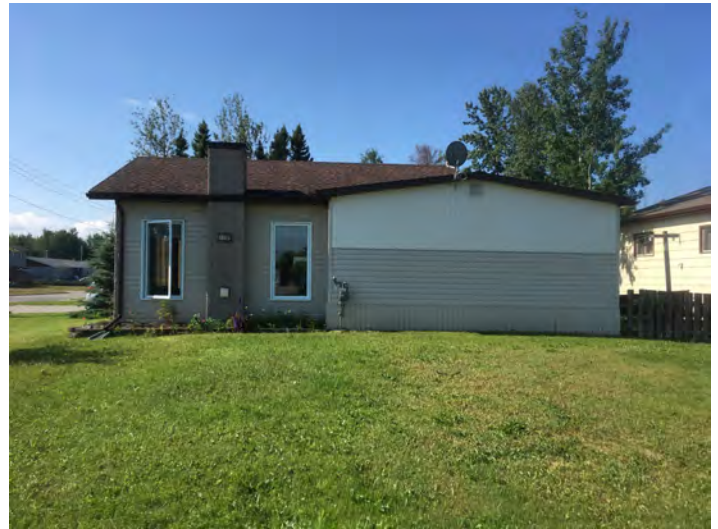
Description: This property contains a residence and outbuilding. The residence is a one storey structure with a medium-pitched cross gable roof that has asphalt shingles, and a brick clad chimney. The exterior has modern siding and windows, and an undetermined foundation. The outbuilding is a modern garage located at the rear of the property.

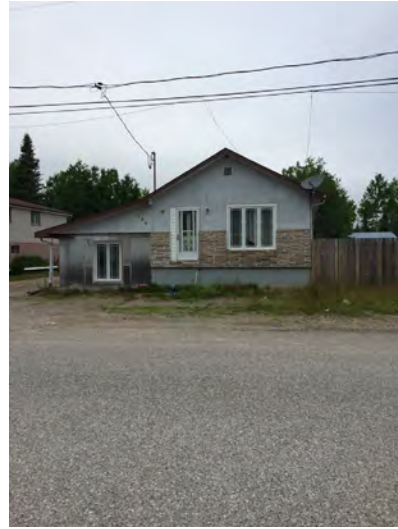
Figure
A

Description: This property contains a residence. The residence is a one storey structure with a steeply-pitched front facing gable roof that is clad in metal. The exterior has an asymmetrical front elevation with a partial wood porch. The residence has modern windows and modern siding, and decorative siding over its foundation.

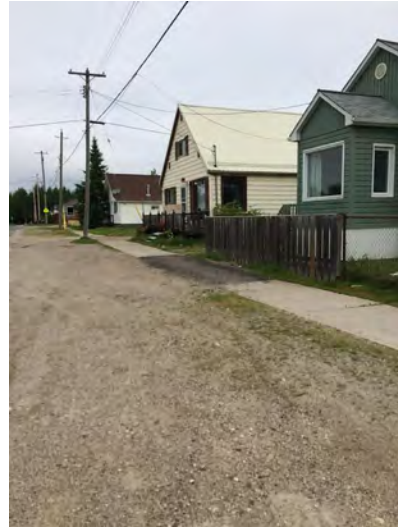
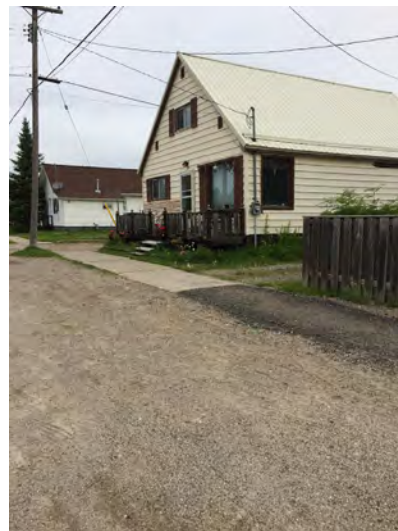
Figure
A

Description: This property contains a residence. The residence is a one storey structure with a medium-pitched front facing gable roof with asphalt shingles. The exterior has an asymmetrical front elevation, with modern windows and modern siding. The residence has a shed roof enclosed entrance porch and a concrete foundation.

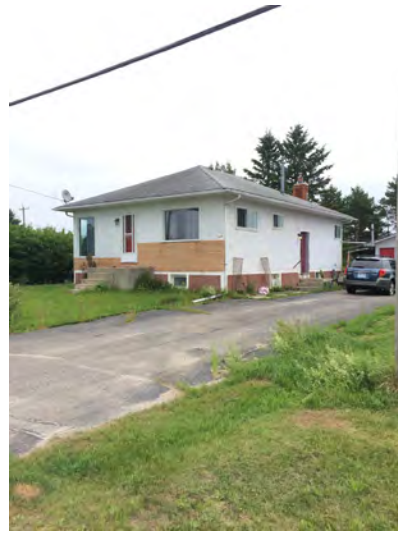
Figure
A

Description: This property contains a residence. The residence is a one storey structure with a low-pitched front facing gable roof and has a shed roof addition. The exterior has modern siding, modern windows, and a partial wooden entrance porch. The residence's foundation is covered with siding.
