**Greenstone Pipeline Project:
Environmental Report**

FINAL REPORT

August 9, 2021

Prepared for:
Enbridge Gas Inc.
50 Keil Drive
Chatham ON N7M 5M1

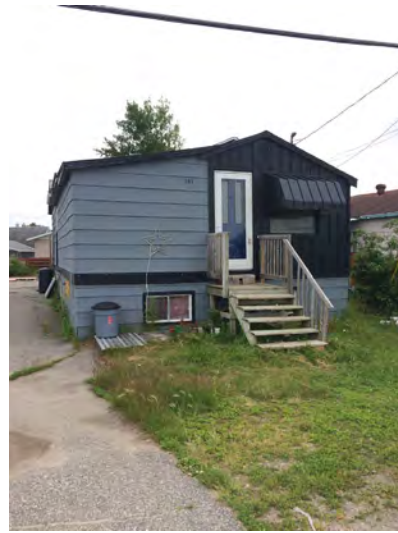
Figure
A

Description: This property contains a residence and an outbuilding. The residence is a one storey structure with a low-pitched gable roof that has asphalt shingles. The exterior has modern siding, modern windows, and a foundation covered by siding. The outbuilding is modern and located at the rear of the property.

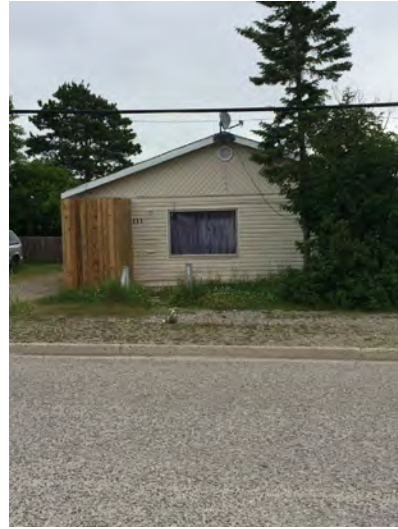
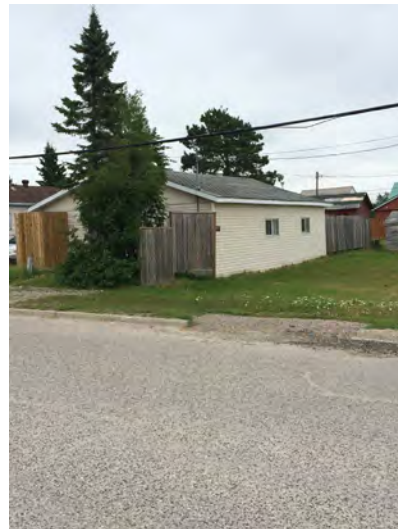
Figure
A

Description: This property contains a residence. The residence is a one and a half storey structure with a medium-pitched front facing gable roof, with a gabled dormer. The symmetrical front elevation has an enclosed full width porch. The exterior has modern windows and siding, and the foundation is covered with siding.

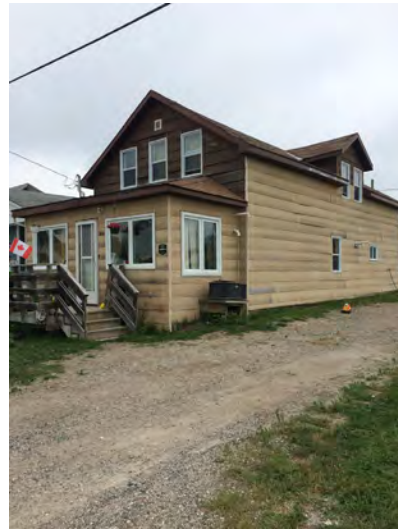
Figure
A

Description: This property contains a residence. The residence is a one storey structure with a low-pitched front facing gable roof. The building has a gabled roof addition on its east elevation. The exterior has modern windows and siding, and a partial entry porch. The residence's foundation is covered with siding.

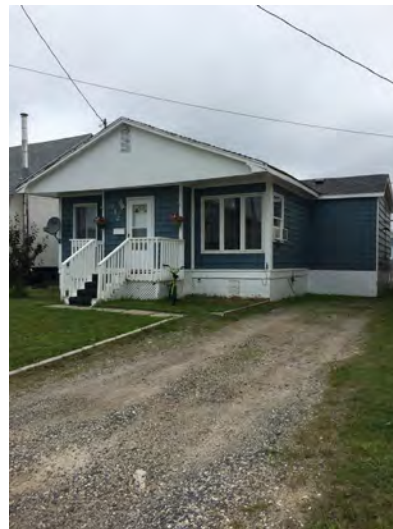
Figure
A

Description: This property contains a residence. The residence is a one storey structure with a low-pitched side gable roof that is clad in metal. The asymmetrical front elevation has a partial entrance porch. The exterior has modern windows and siding, and a concrete foundation.

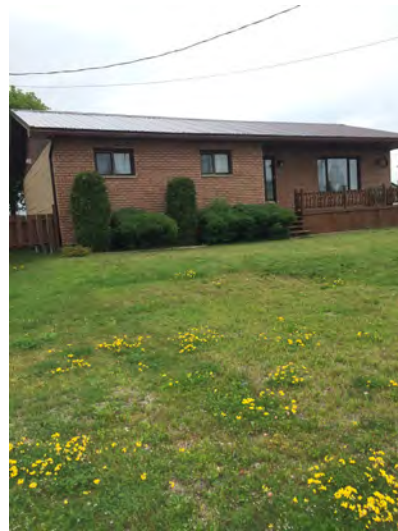
Figure
A

Description: This property contains a residence. The residence is a one storey structure with a high-pitched front facing gable roof. The exterior of the residence has modern windows and siding, and a concrete foundation. The asymmetrical front (south) elevation has a partial wood entrance porch.

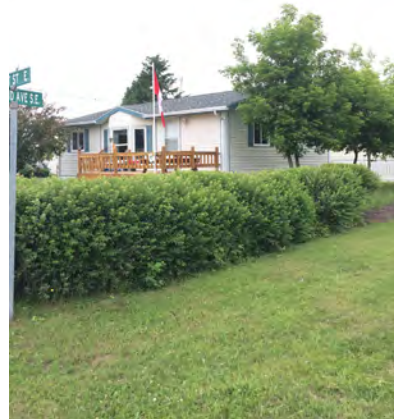
Figure
A

Description: This property contains a residence. The residence is a one storey structure with a low-pitched shed roof. The front (north) elevation has an enclosed entrance porch. The structure has modern siding, and windows. The west elevation has a partial entrance porch. The residence's foundation is covered by wood.

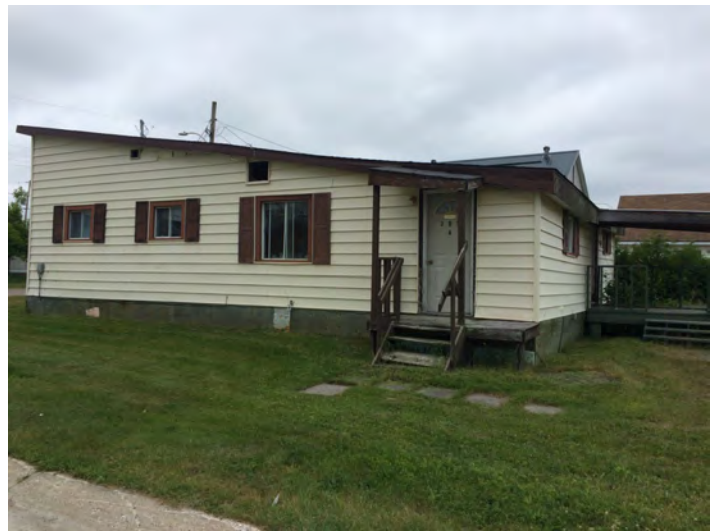
Figure
A

Description: This property contains a residence. The residence is a one and a half storey structure with a low-pitched front facing gable roof. The exterior has modern windows and siding, and a concrete block foundation. The front (east) elevation has a partial wood porch.

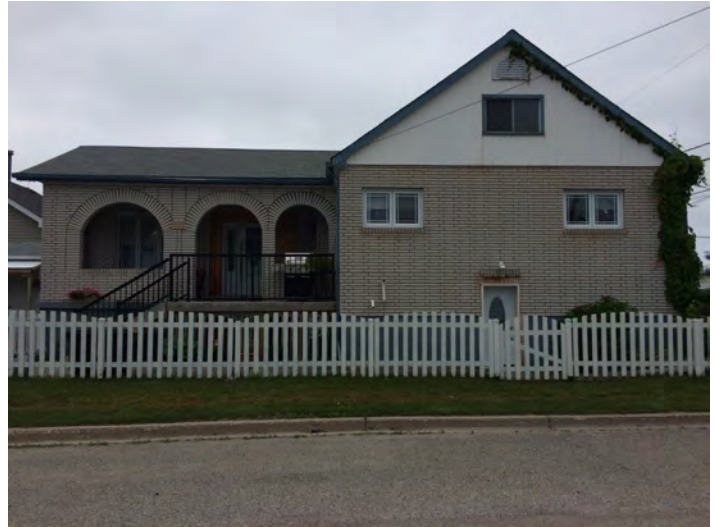
Figure
A

Description: This property contains a residence and an outbuilding. The residence is a one and a half storey structure with a steeply-pitched front facing gable roof, that is clad in metal. The symmetrical front (south) elevation has a central projecting enclosed entrance. The exterior is clad in modern siding and has modern windows. The residence's foundation is covered by wood. The outbuilding has a side gable roof and is clad in modern siding.

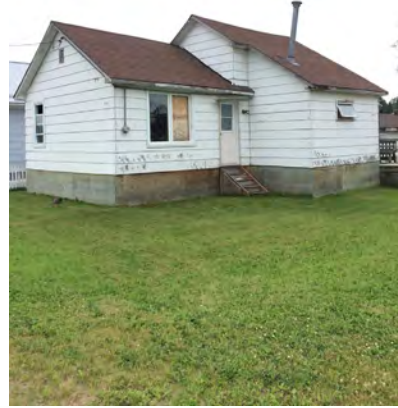
Description: This property contains a residence and a modern outbuilding. The residence is a one storey structure with a medium-pitched multiple gabled roof. The roof is clad in asphalt shingles and has a metal chimney. The exterior has modern windows and siding. The residence's foundation is covered with wood.

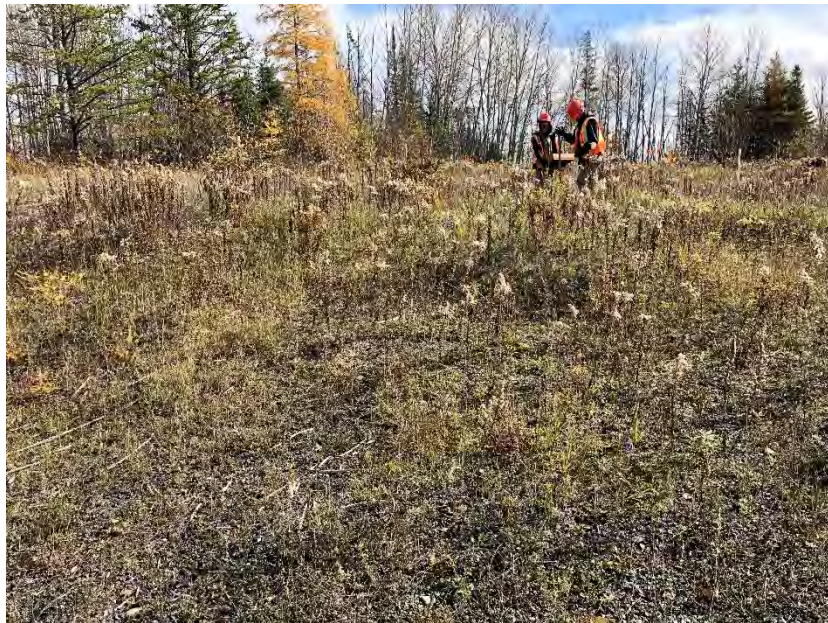
Photo 1: Stage 2 test pit survey at five metre intervals, facing northeast

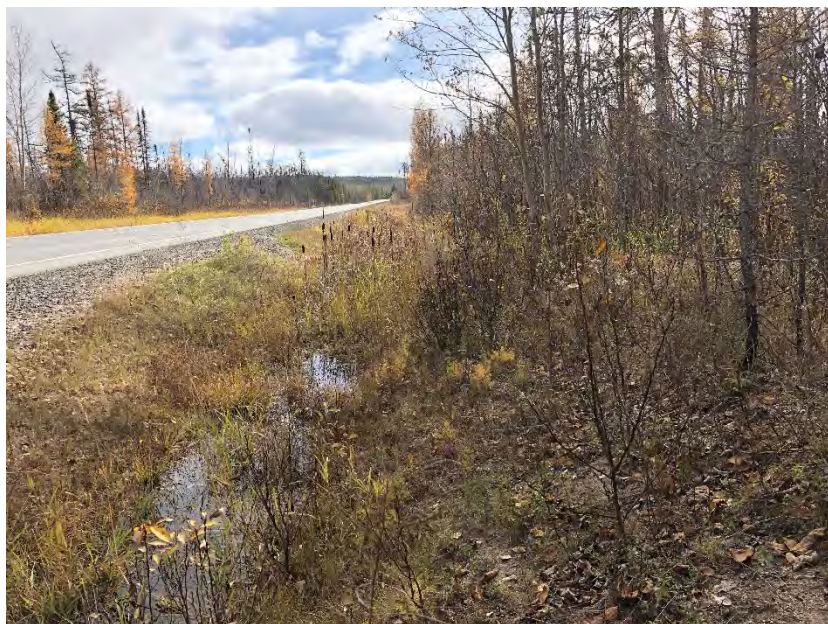
Photo 2: Permanently low and wet area and not surveyed, facing south

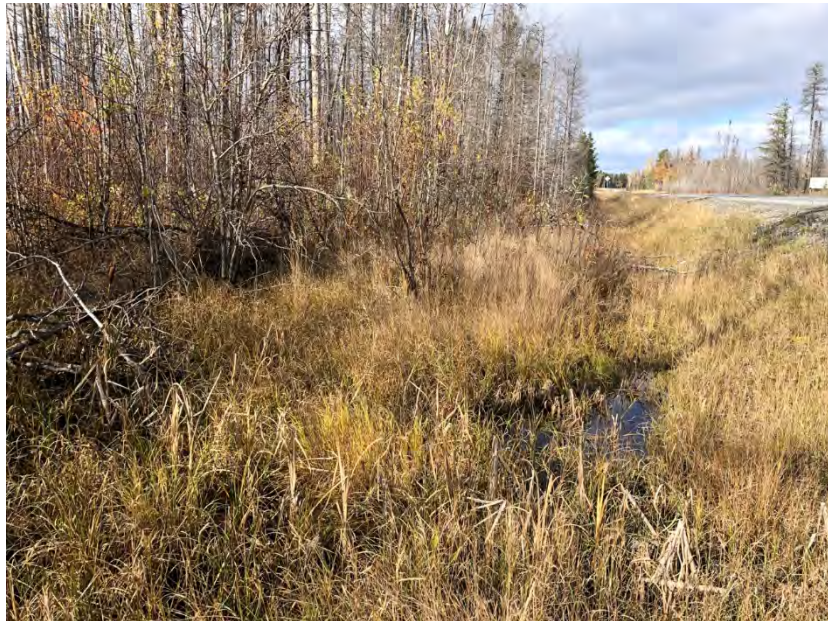
Photo 3: Permanently low and wet area and not surveyed, facing northwest

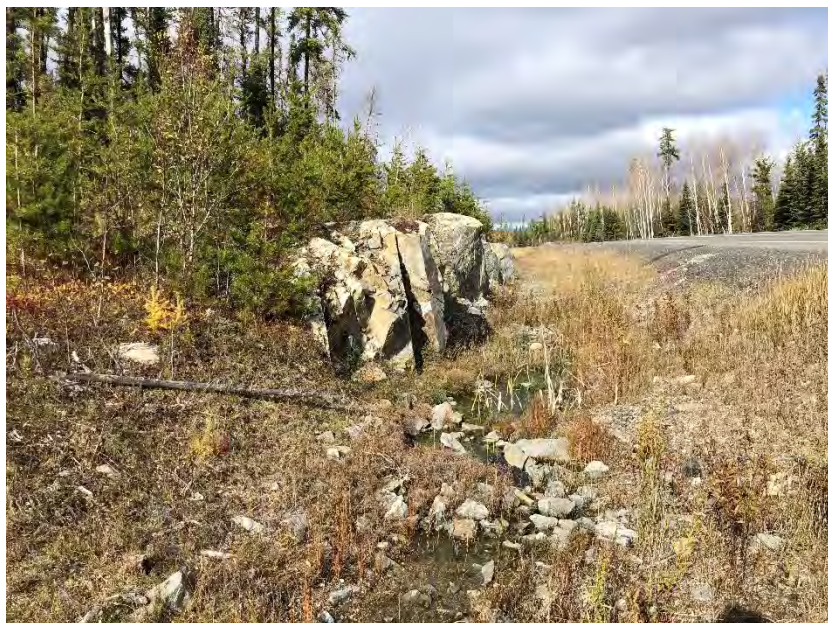
Photo 4: Area of exposed bedrock and not surveyed, facing northeast

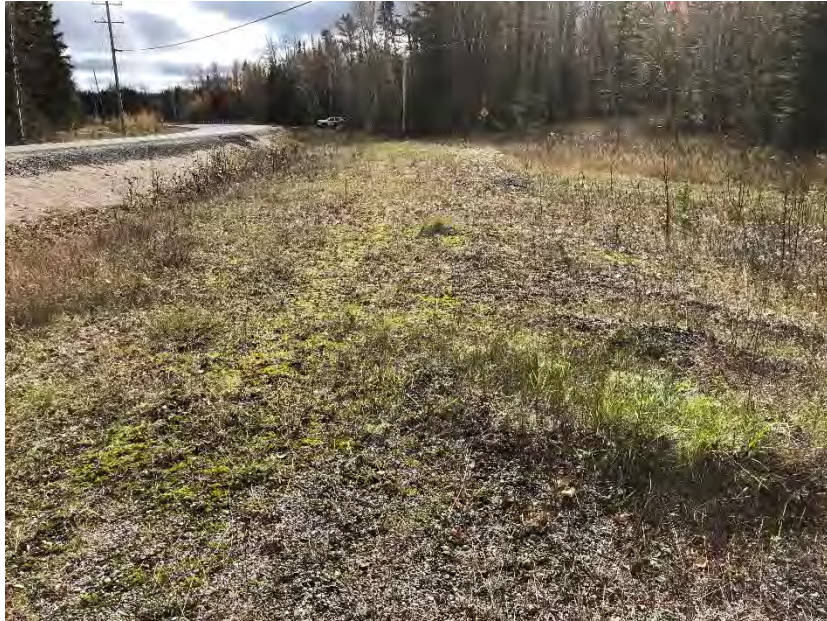
Photo 5: Disturbed area due to ditching, grading, and hydro line construction – not surveyed, facing south

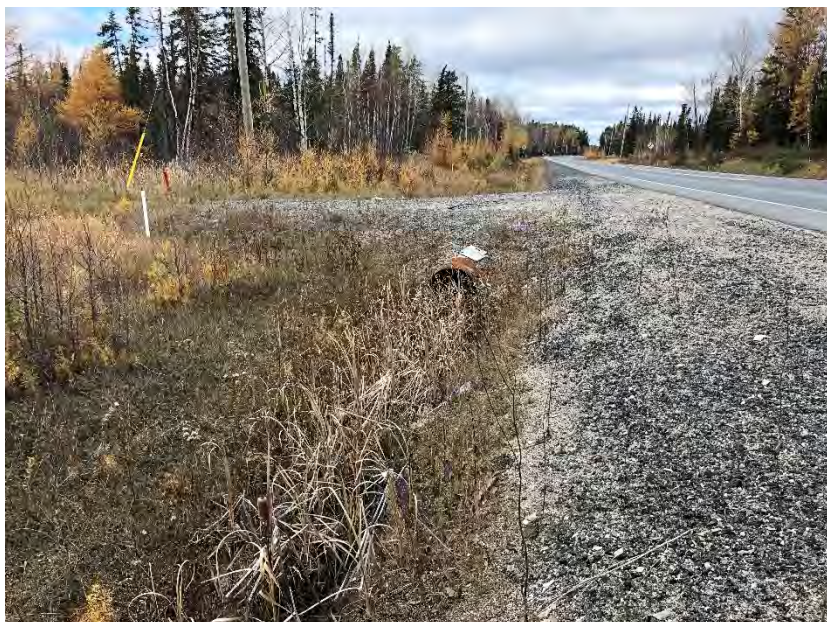
Photo 6: Disturbed area due to grading, ditching and installation of road and culvert – not surveyed, facing north

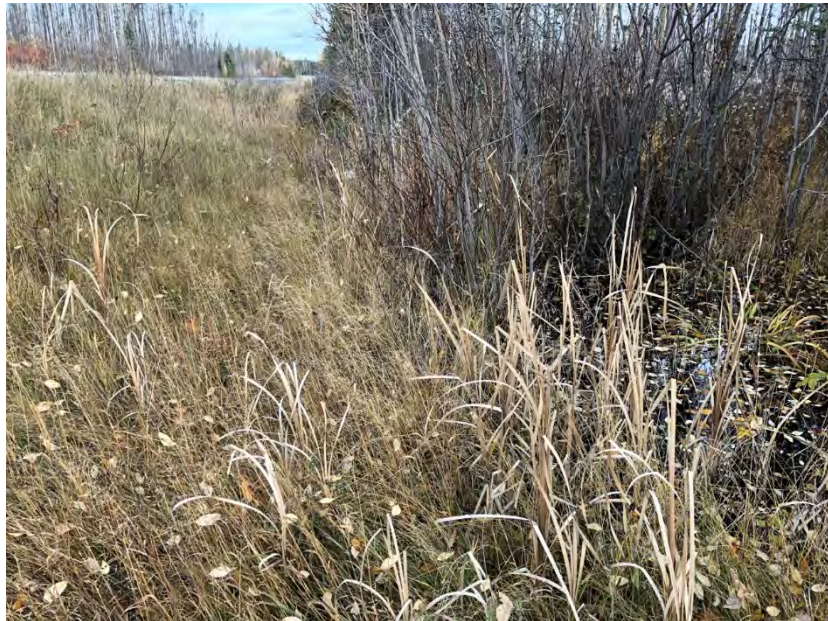
Photo 7: Permanently low and wet area and not surveyed, facing northwest

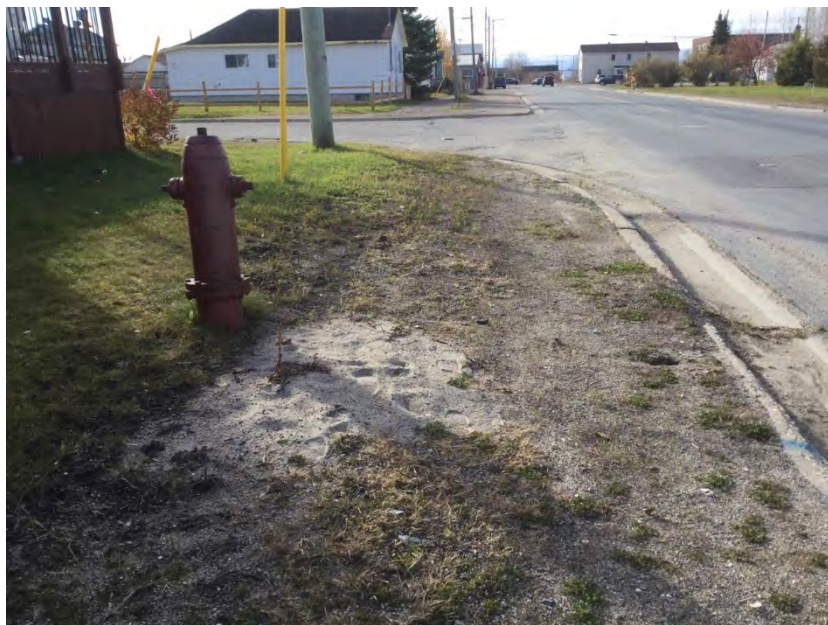
Photo 8: Disturbed area due to the installation of buried utilities – not surveyed, facing south

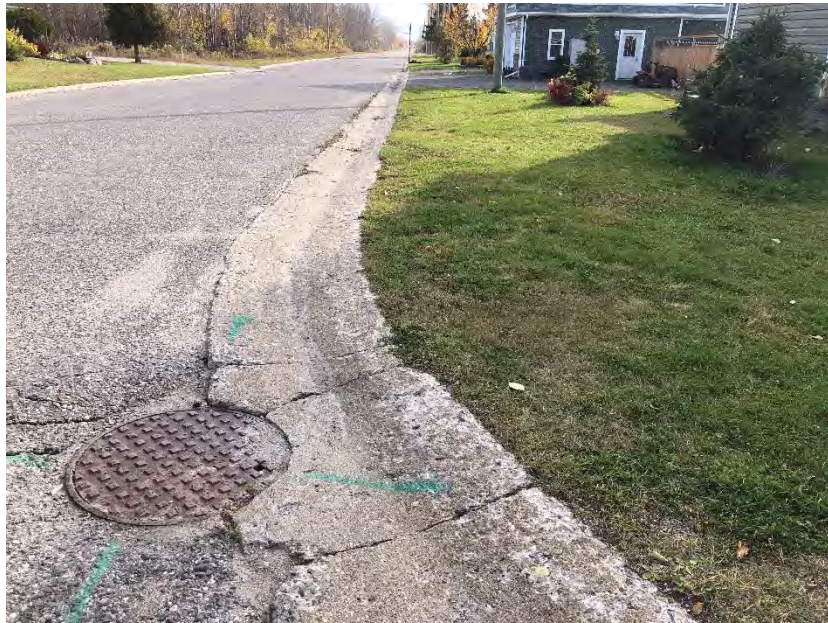
Photo 9: Disturbed area due to the installation of buried utilities – not surveyed, facing southwest

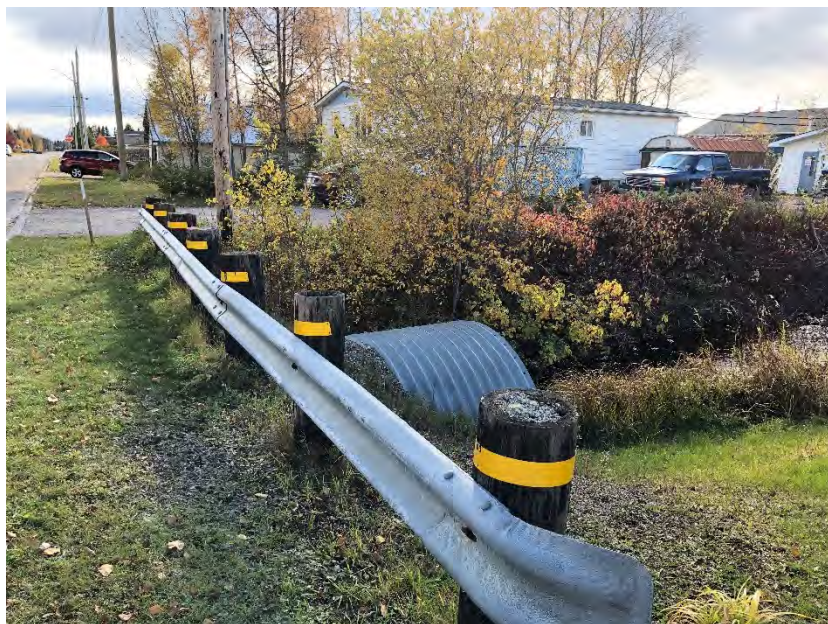
Photo 10: Disturbed area due to ditching and culvert installation – not surveyed, facing southwest

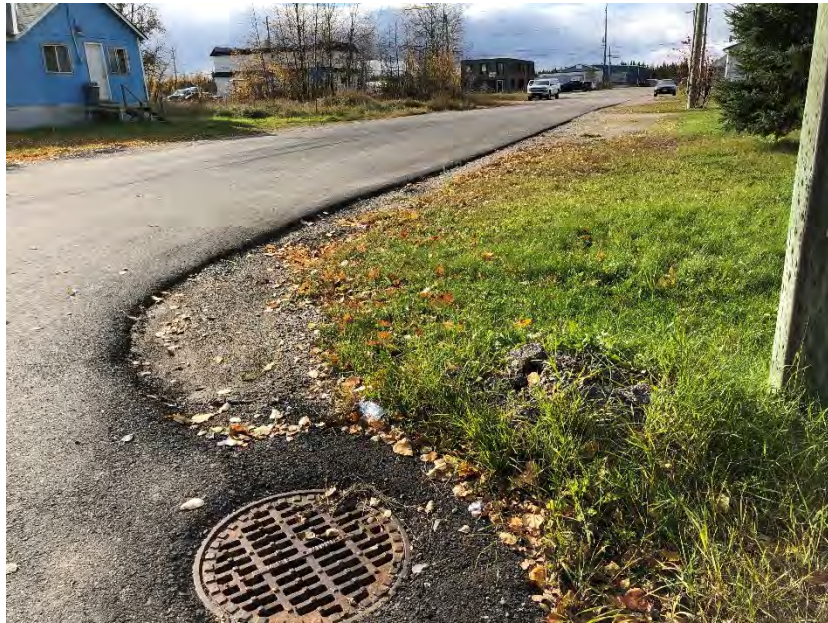
Photo 11: Disturbed area due to grading for road and utility installation – not surveyed, facing west

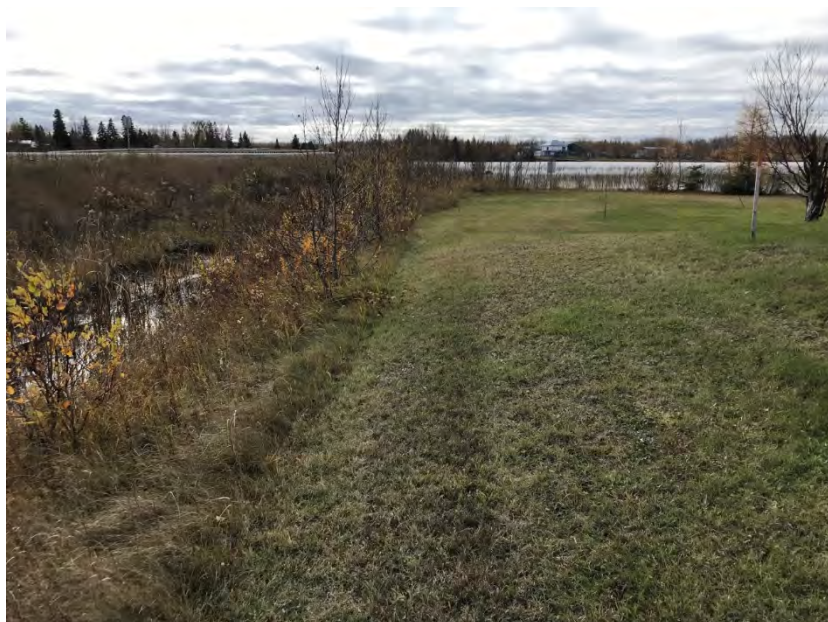
Photo 12: Disturbed area due to ditching from road and bridge installation – not surveyed, facing south

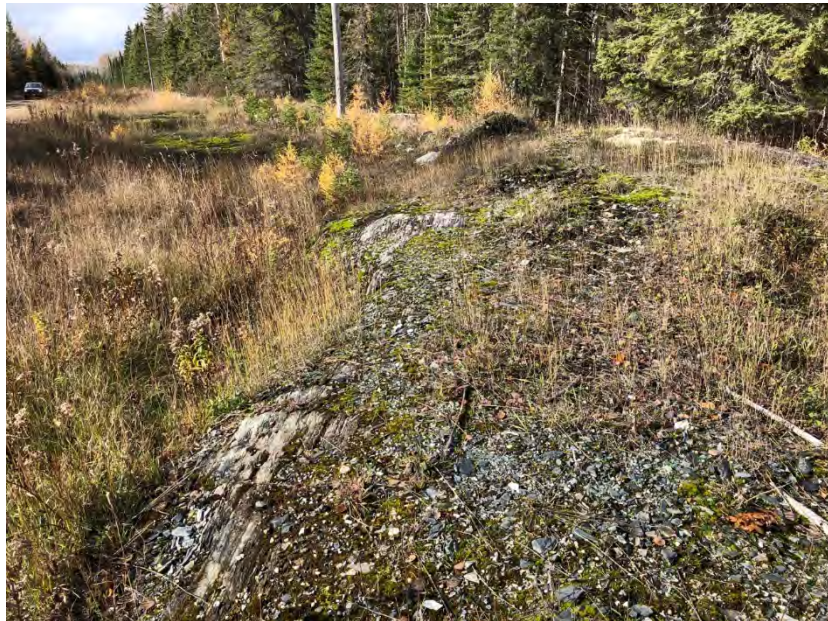
Photo 13: Area of exposed bedrock along Old Arena Road, not surveyed, looking southwest

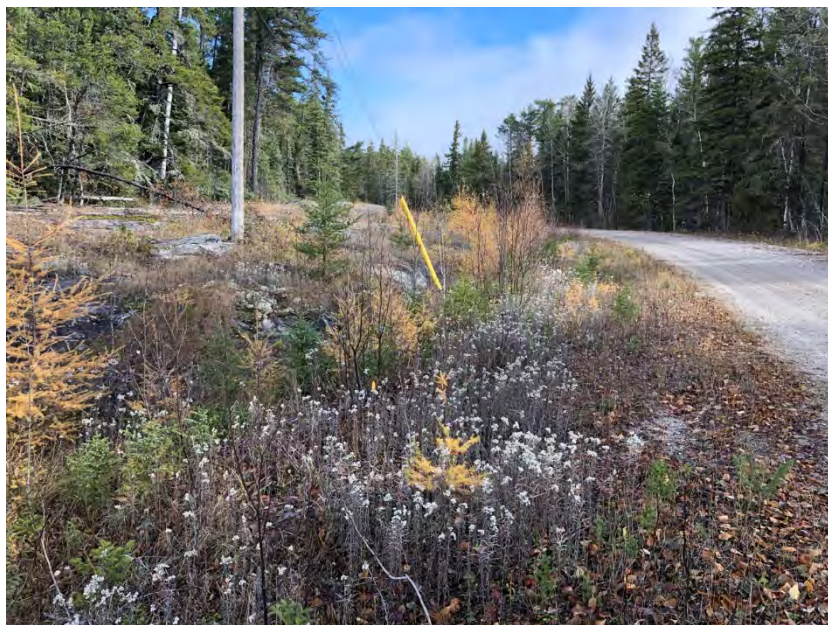
Photo 14: Area of exposed bedrock and not surveyed, looking southwest

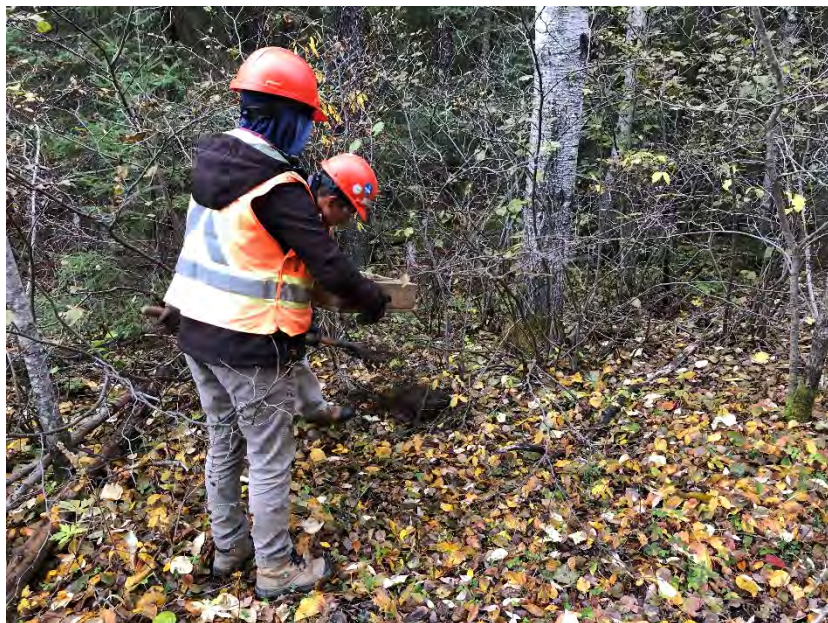
Photo 16: Stage 2 test pit survey at five metre intervals, facing east

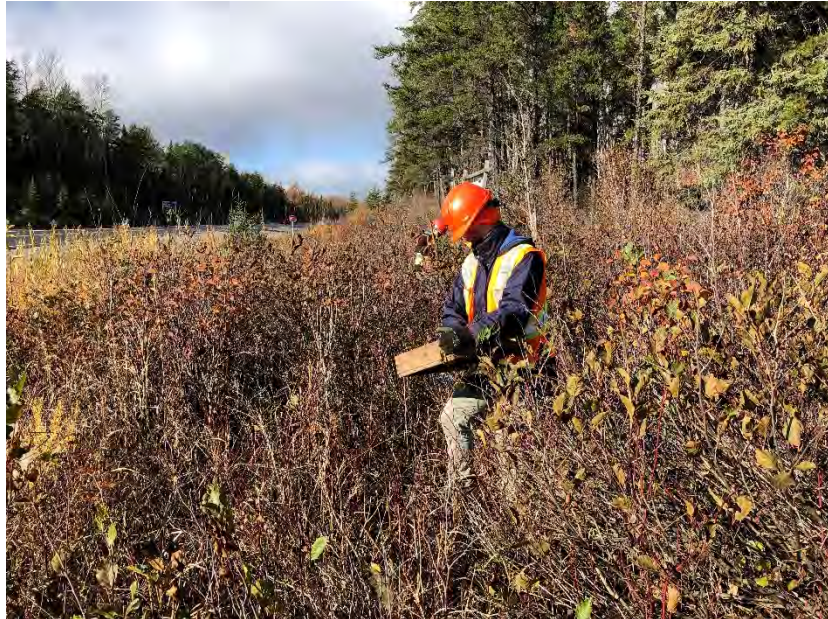
Photo 17: Stage 2 test pit survey at five metre intervals, facing west

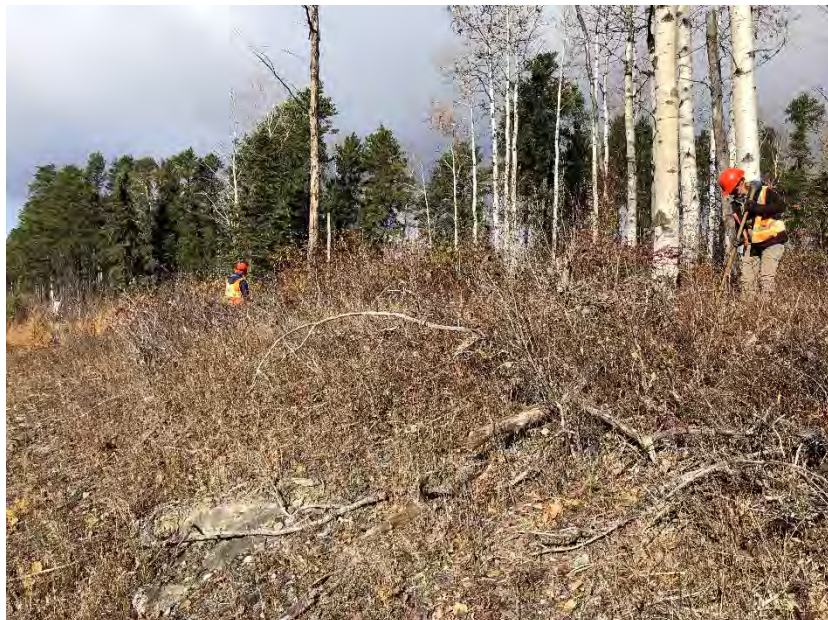
Photo 18: Stage 2 test pit survey at five metre intervals, facing northwest

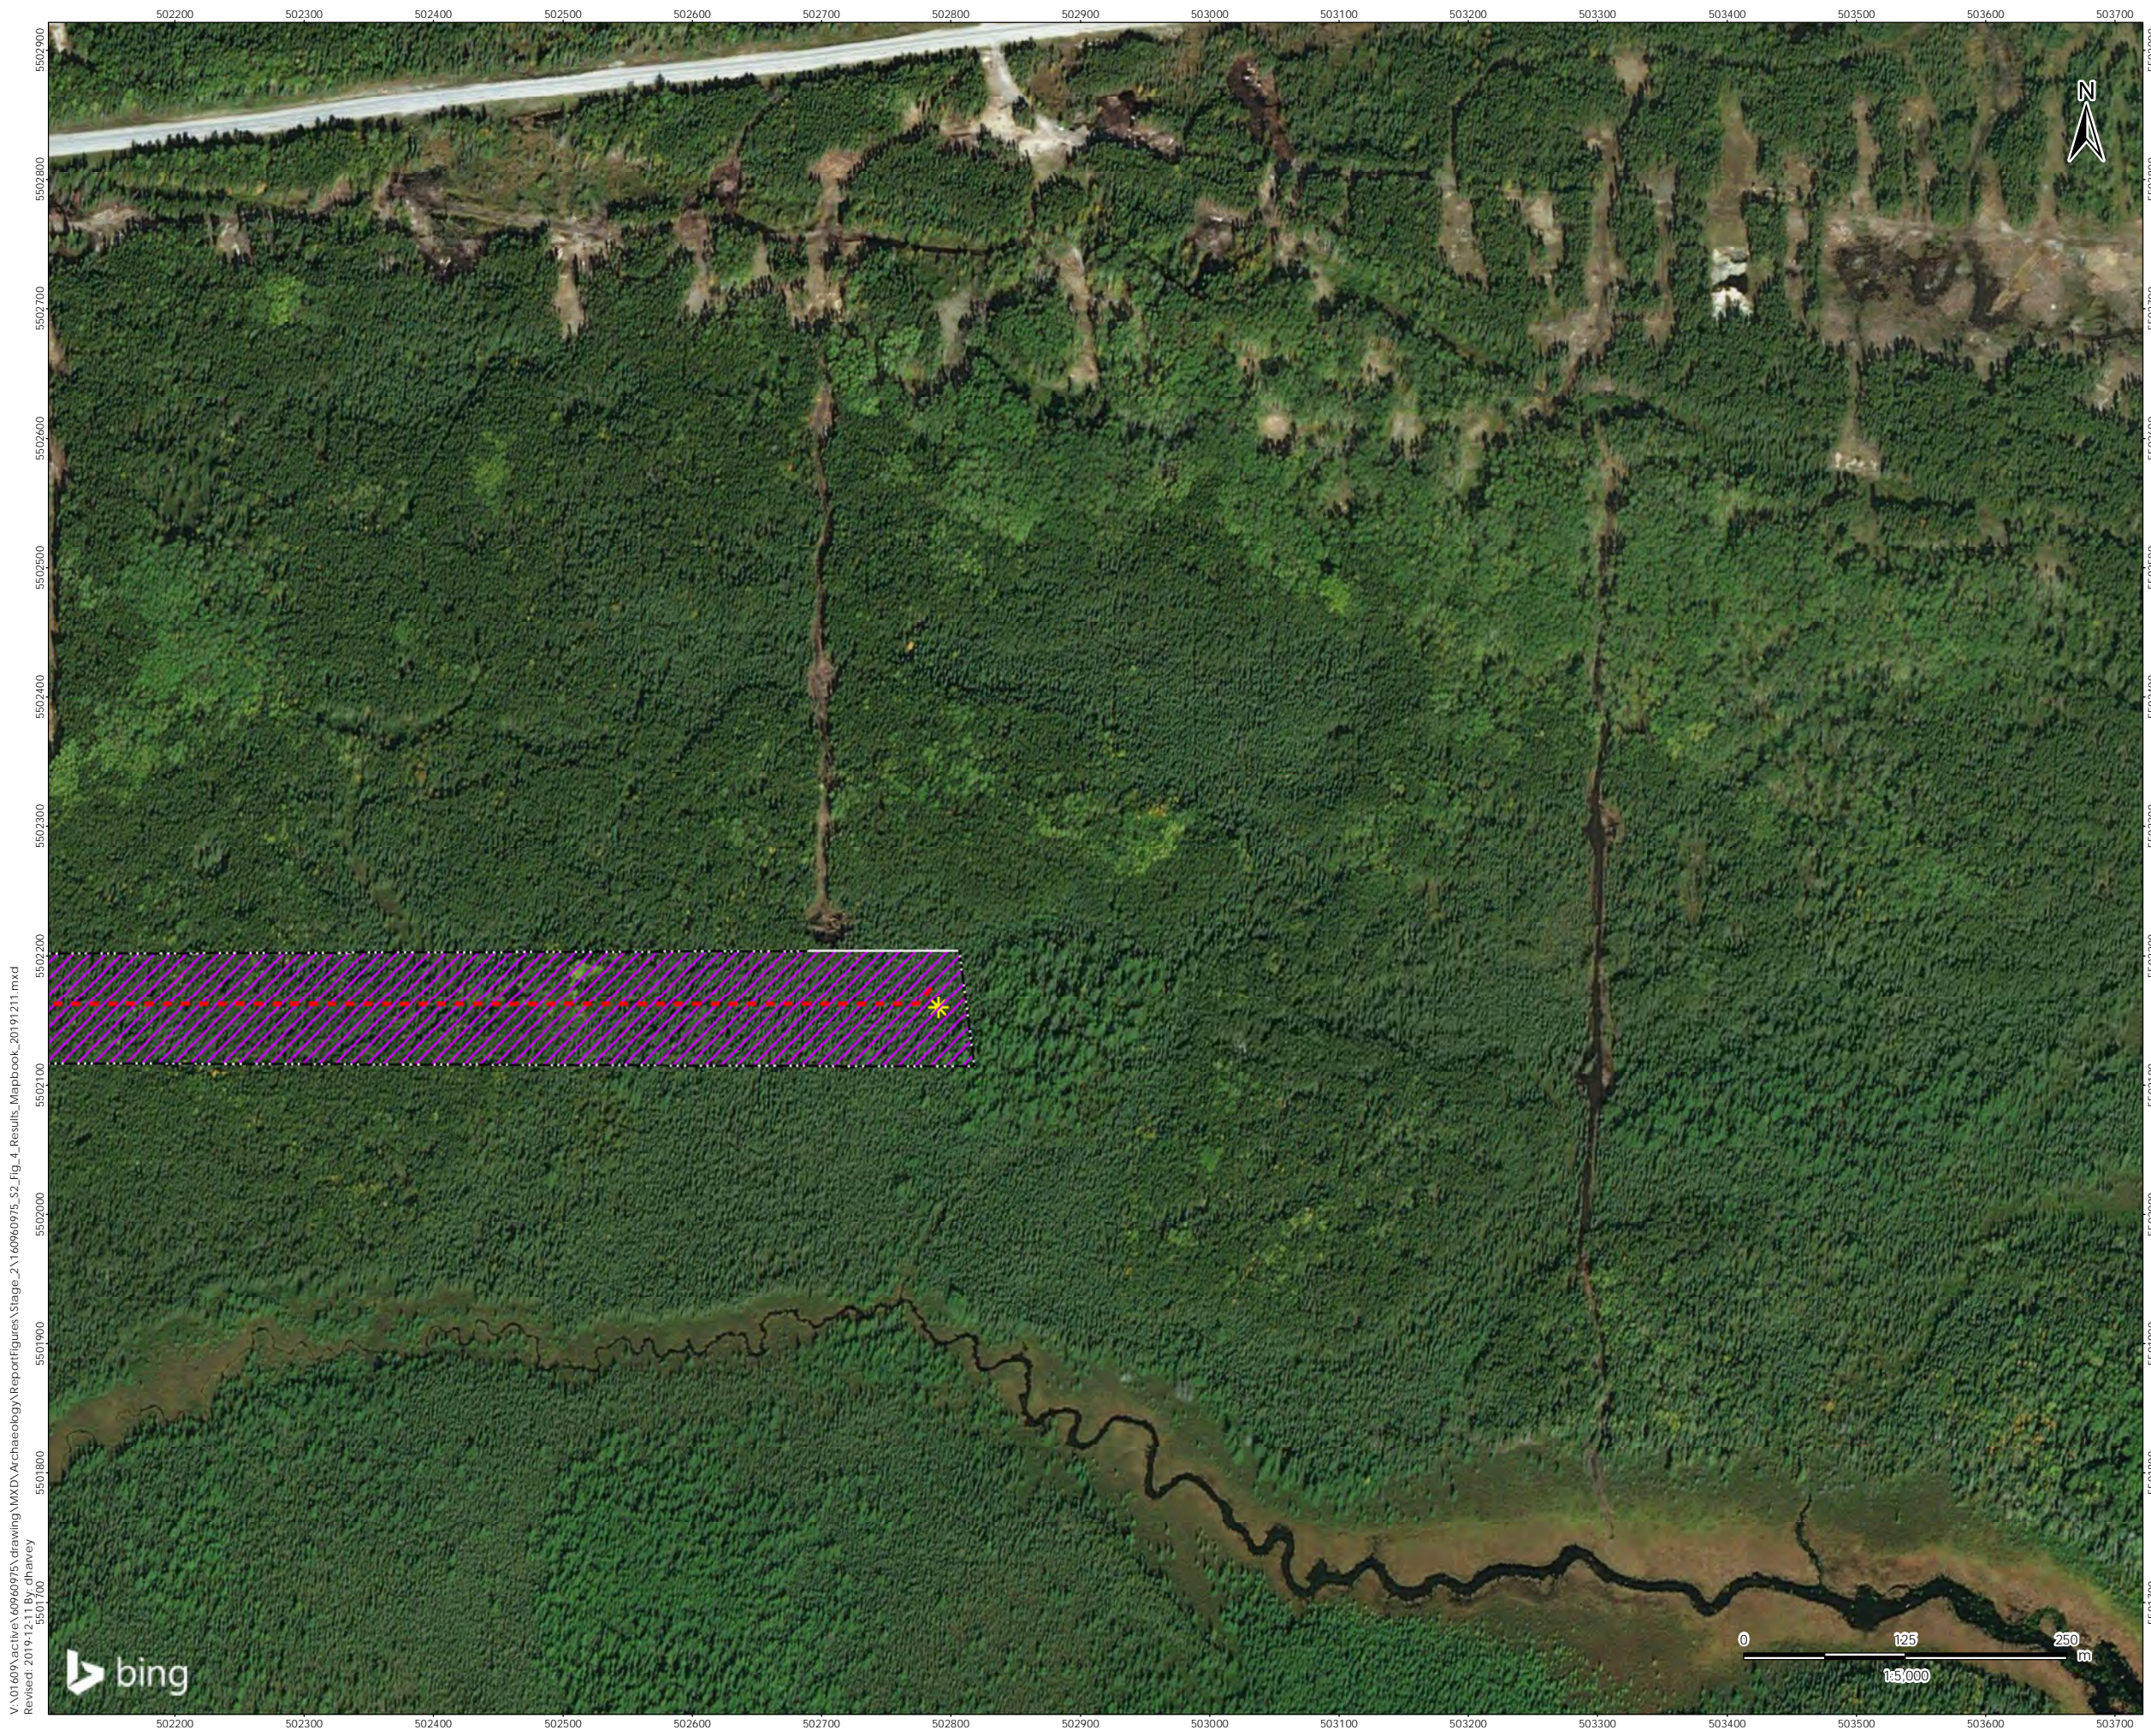
Figure No.
 4 - J

Title
 Stage 2 Archaeological
 Assessment Methods

The report documents the assessment of the study area as depicted in Figures 4-A to 4-J of the above titled report and recommends the following:
